2004 INDIAN OCEAN TSUNAMI ON THE MALDIVES ISLANDS: INITIAL OBSERVATIONS

**Barbara H. Keating and Charles Helsley,
University of Hawaii, HIGP/SOEST, 2525 Correa Rd. Honolulu, HI 96822
Zaha Waheed, Marine Resources Research Center, Maldives Islands
Dale Dominey-Howes, Risk Frontiers, Macquarie University, Sydney, NSW 2109
Australia**

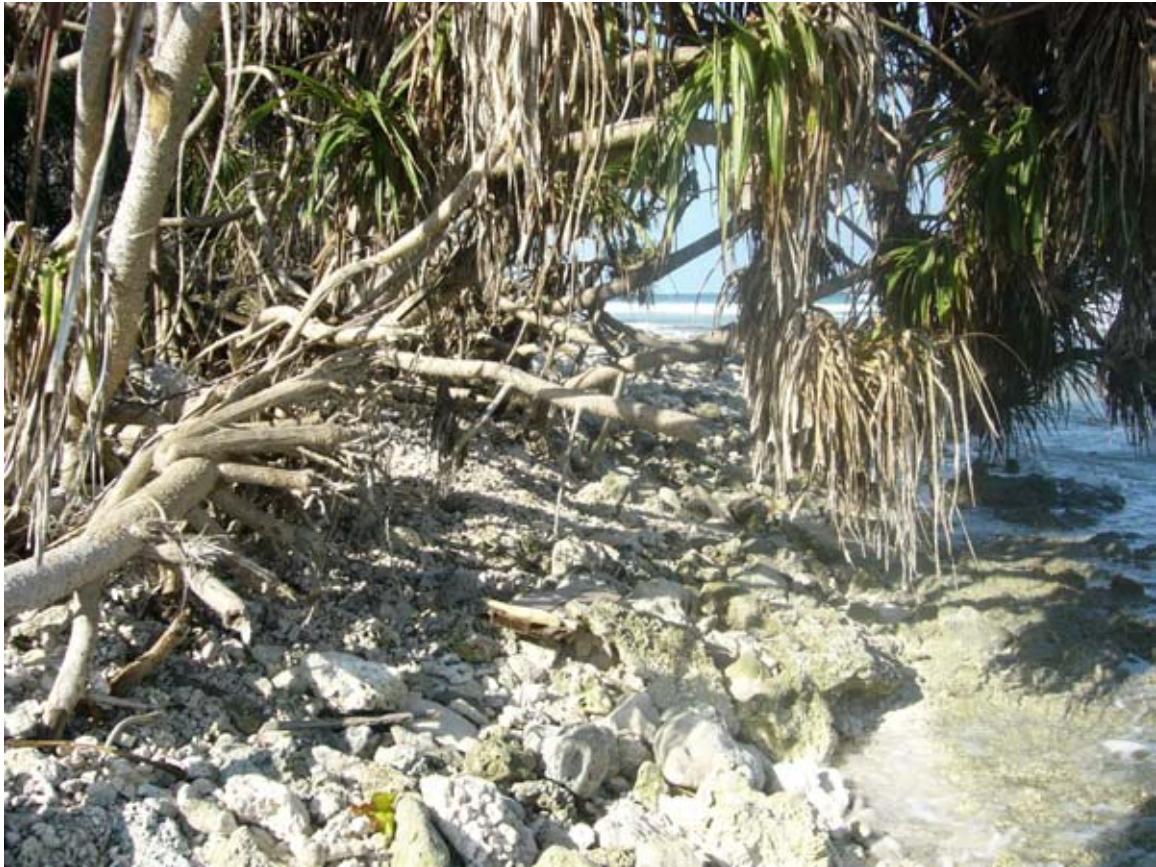
Figure 4. This tree is the *Pandanus* tree. Because the tree proves a broad cross-section to the sea, it stopped corals from being transported onto the surface of the island. These trees were buried in several cms of coral clasts.

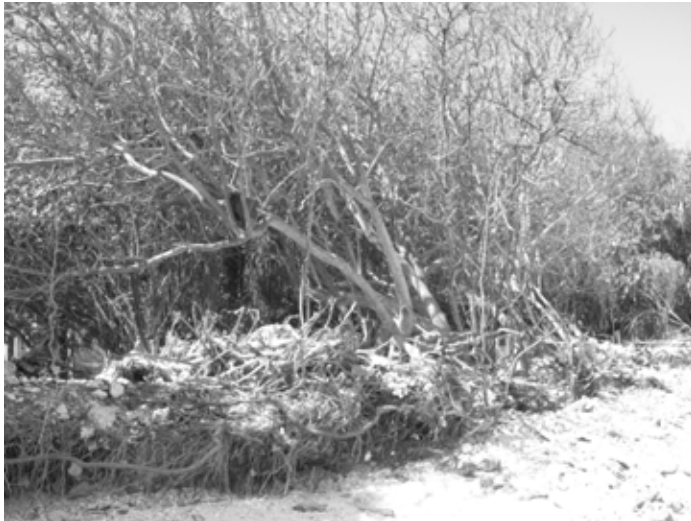
Figure 3. The vegetation on the east side of Kandooma was crushed by the tsunami and laid backyards toward the center of the island. The leaves were stripped from the trees. The roots of the vegetation were undermined and the coral from the littoral zone was trapped within the vegetation. But, the vegetation provided important protection to the buildings nearby.

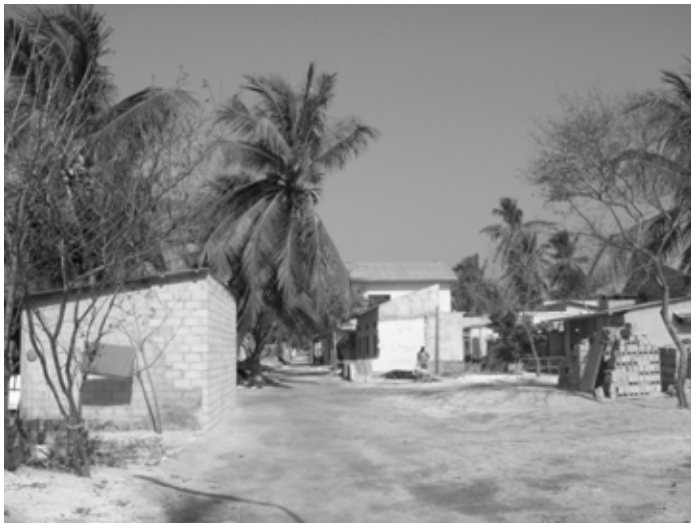
Figure 14. The hollow blocks used for construction in Guraidhoo are about 12 cm wide. This photograph above shows the construction blocks at right and a newly repaired building at left. The small building has new construction on the right side where the wall was lost during the tsunami, but the remainder of the structure pre-dates the tsunami. The roof is corrugated metal. The buildings are being constructed in the pre-tsunami manner and still lack reinforcing and foundations.

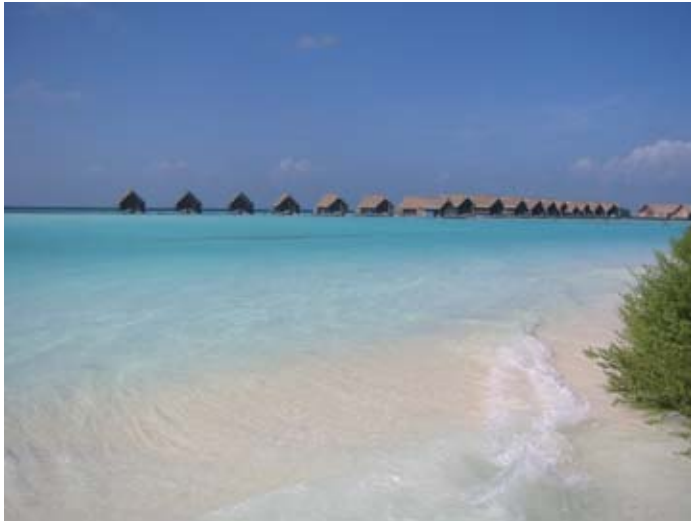
Figure 19. These are the bungalows built on concrete poles within the Cocoa Island resort lagoon. The walkways and the bungalows survived with very little damage. Fortunately the tsunami only reached the base boards of the bungalows, leaving the structures intact.
