REVIEW OF RECONSTRUCTION IN ACEH FOLLOWING THE 2004 BOXING DAY TSUNAMI

Zygmunt Lubkowski¹, Jo da Silva², Kubilay Hicyilmaz³ and Damian Grant⁴

ABSTRACT

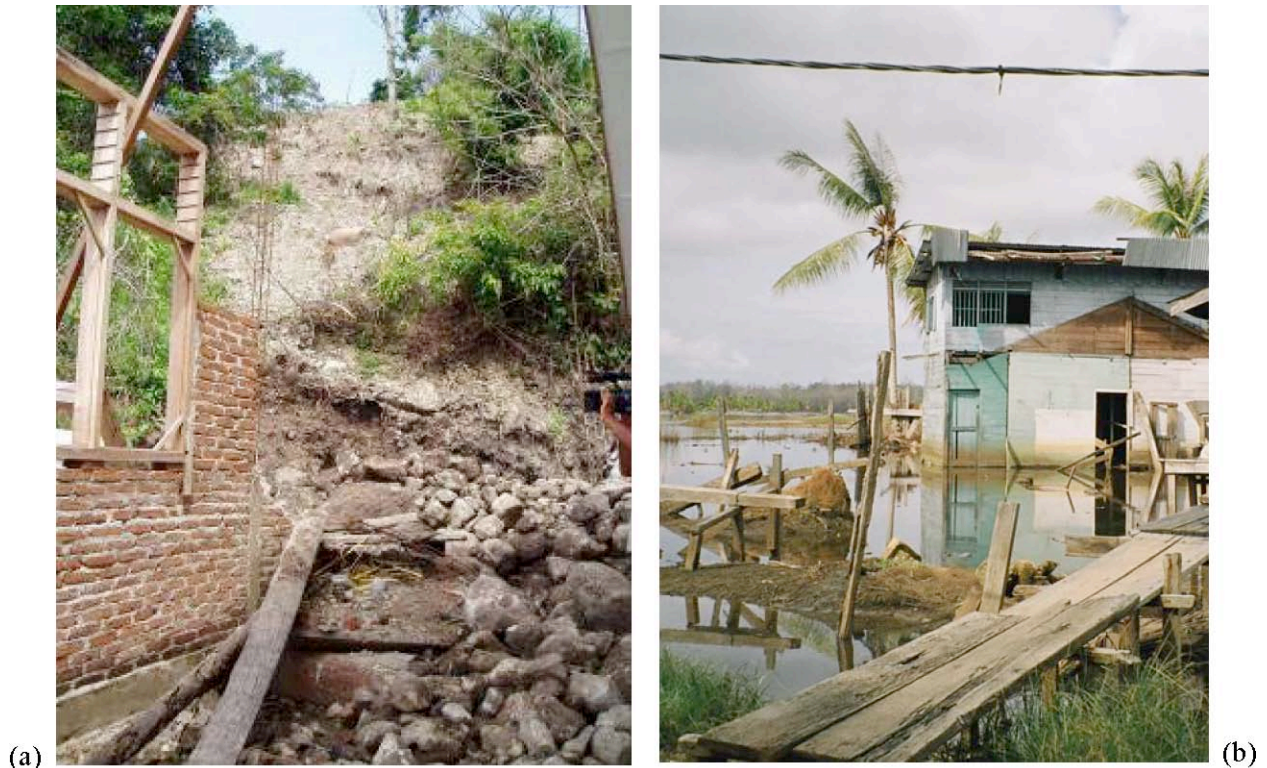
The average rainfall for Banda Aceh is about 1.6m in a year, with the principal rainy season being between September and January. The region is therefore susceptible to large water run-off that can lead to flash flooding. This requires adequate drainage design. Locating housing on high ground, or elevating it on stilts reduces the impact of flooding. Where developments are to be built on or near slopes, it is important that terraces and drainage channels are sufficiently engineered to ensure their stability (Figure 2a).

Flooding can also occur due to changes in topography following major earthquakes. Following the 26 December 2004 and 28 March 2005 earthquakes, the Sunda Plate has sunk by about 1m with respect to sea level. This has had a dramatic effect on towns such as Singkil (Figure 2b) and Rigaih, where large areas have been “lost to the sea” or highly susceptible to tidal flooding (the maximum tidal range along the Aceh coast is about 1.5m). As a result many villages have been displaced or have been made uninhabitable.

Figure 2 Examples of housing a risk due to non-tsunami hazards (a) landslides due to rainfall (b) inundation by the sea

Where there has been significant loss of coastline due to large scale plate movements, one must consider the future viability of the affected settlements. Engineering solutions can be provided, but they will require detailed investigations and significant civil engineering works to provide a safe, flood free environment. Hydrological and topographical surveys will be needed to assess the validity of potential re-location sites, and re-location carefully planned to ensure access to utilities, community

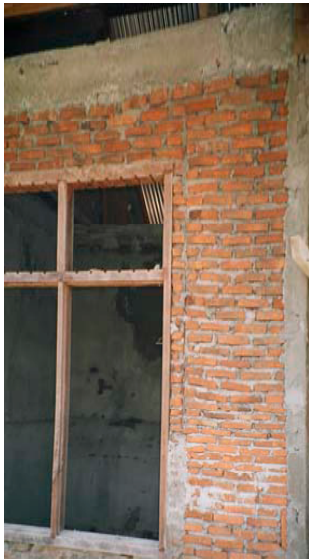
Openings/Wall Panels

During our first visit it became clear that the requirements of the Building Code were not being enforced, and many houses built at that time did not comply with these basic requirements (see Figure 3). Furthermore, it is noted that most international codes have restrictions on the use of unreinforced masonry for regions of moderate and high seismicity, such as Aceh. However, the Building Code for Aceh permits the use of masonry for walls panels, but provides no guidance on fundamental seismic principles including: maximum size of wall panels, openings in wall panels, minimum thickness of wall panel, tying of wall panels and provision of ring beams.

- The design and workmanship quality for many houses (reinforced concrete frame with unreinforced masonry infill) were found to be very poor when reviewed using the FEMA 154 approach. Many new constructions are thought likely to collapse in the next major earthquake.

Figure 3 Examples of poor workmanship

- Experienced earthquake engineers should survey structures that survived the earthquake of 26 December 2004 and address the issue of retrofitting.
- Experienced engineers should develop a basic and comprehensive code of practice for post-tsunami housing, and possibly a complimentary training programme to reinforce it.

- Procedures should also be developed to regulate the quality of construction. These are critical to deliver a product that is fit for purpose, and reduce vulnerability to future events. In particular experienced engineers should review construction of critical facilities; hospitals, schools, bridges etc.
- An education programme on hazards should be implemented at all levels of government, in NGOs, and within the wider community to raise awareness.
