## SCIENCE OF TSUNAMI HAZARDS

### MECHANISM OF SEAWALL DESTRUCTION DUE TO TSUNAMI

Tsunami that happened along Sunda Strait on 22 December 2018 was generated by the collapse of the flank of Anak Krakatau volcano in Indonesia. The tsunami hit Lampung and Sunda beaches areas. The hydrodynamic force of the tsunami hit everything on its course severely including seawalls that are used to protect the beach from erosion due to wind waves. The stability of such structure is limited to the design wind wave force. Tsunami has a significantly different nature compare to wind waves. When tsunami arrives at the coastline it becomes surge where, the water particle movement is significantly faster than that of the wind waves. The force of such high speed of water particles at a seawall may destroy and drag away the material far from the original location. Field survey was conducted following the tsunami event along Sunda Strait in Banten area. Based on the survey, a hydraulic simulation of seawall destruction due to tsunami was carried out in the laboratory. It was found that there were two distinct mechanisms of seawall destruction. When the land support of the seawall is relatively weak, the

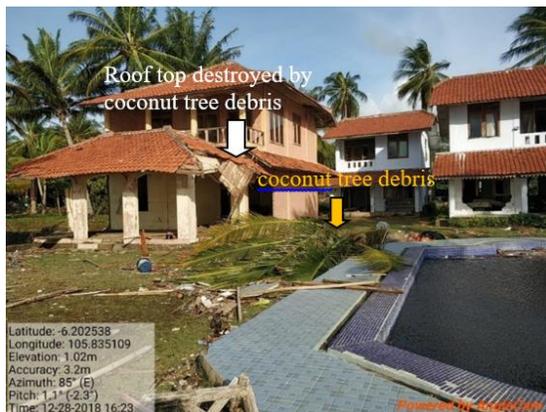
At Kelapa Jangkung beach, it can be seen that coconut tree debris has caused the building near the coast suffered from destruction. Figure 3 suggests that a rooftop was ruined by the debris. At that location the tsunami inundation was less than the roof height, hence the roof of the first-floor must have been ruined by floating debris. The coconut tree that could still be found in front of the building is the most possibly caused of the destruction. In Figure 4, many debris were found in the building adjacent to the building shown in Figure 3. On the right, a brick wall seems to be in a good condition or stable. The car on the background was seriously damaged. Probably the car has been swept by tsunami as debris and hit the building behind it. As can be seen, the car's body was deformed.

Figure 3. The rooftop of the building was damaged by a coconut tree debris

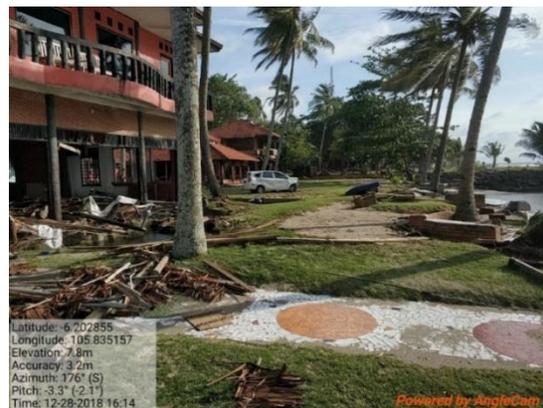
Figure 4. Debris in front of the building

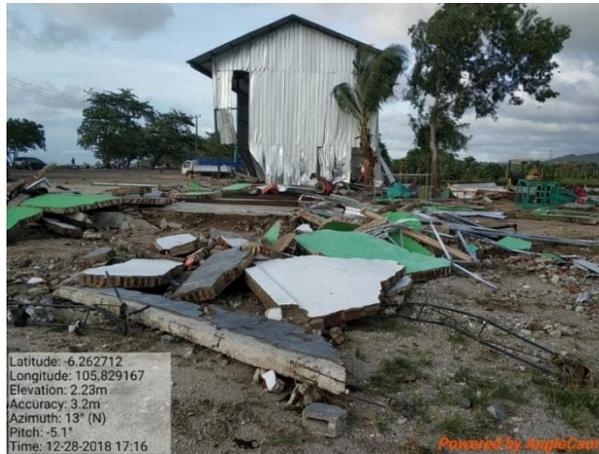
A steel framework warehouse at Sukarame Beach was hit by tsunami as depicted in Figure 5. The lower part of the enclosure that was made of thin steel sheet was destroyed. The warehouse contained a number of agricultural equipment and machineries such as tractors that were for sales. When tsunami hit the building, all the equipment was washed away as debris and probably has caused further destruction to the enclosure. Some of the equipment was found approximately 150 m from the warehouse. Since there was no building behind the warehouse the debris could have rolled freely into the agricultural area. The debris indicated the strength of the tsunami in this area. Another indicator that demonstrated the strength of tsunami at this location is the fact that a building of brick wall with reinforce concrete frame was completely demolished. The wall with reinforce concrete was much more brittle when compare with the steel building. The ruins have become debris where some of them were drifted landward by tsunami. Approximately 300 m to the south from the warehouse location was a small container hotel location. The hotel was under construction where the containers were prepared near the beach. The containers were swept by tsunami as debris and stopped by trees along the road Figure 6.

Figure 5. The damage warehouse (steel frame, thin sheet steel enclosure) and brick wall with reinforce concrete frame buildings

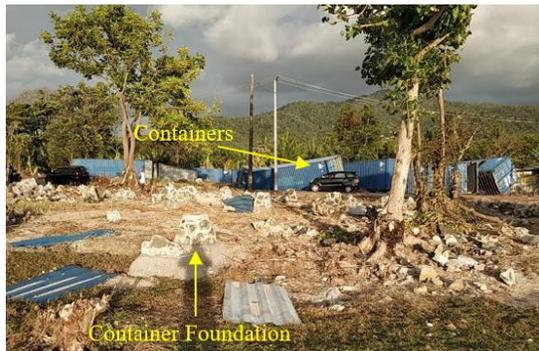
Figure 6. Container structure dragged by the tsunami

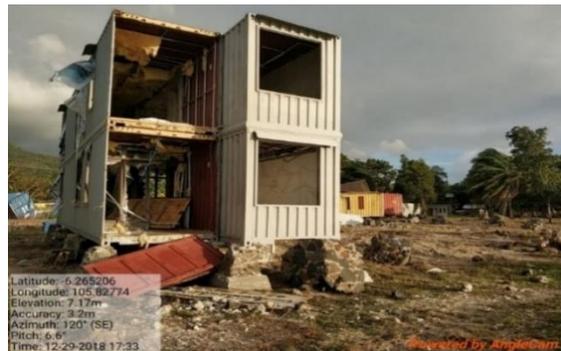
Some of those containers have been installed on top of a stall foundation approximately 60 cm above the land surface. Figure 7 shows the condition of such container building. The tsunami force swept those containers land ward and luckily many of them were stopped by trees.

Figure 7. Survived container building

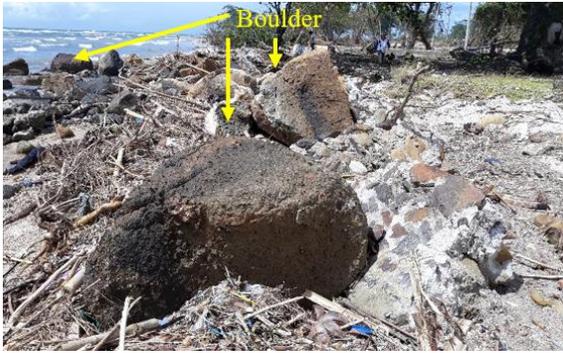
In the survey area, a seawall was destroyed almost completely as shown by Figure 8. A big boulder can be found on top of the ruined. These boulders could have originally been in front of the seawall (sea side) and were drifted by tsunami and finally hit the seawall. The boulder could have added more destruction to the seawall. In different location a very large boulder (3 m in diameter) was also found in land (Figure 9). The boulder could have been drifted tenth of meters from its original position in the beach. This justify that large boulder can be drifted far away by the Sunda Strait tsunami.

Figure 8. Boulders on top of the seawall in Batu Hideung Beach

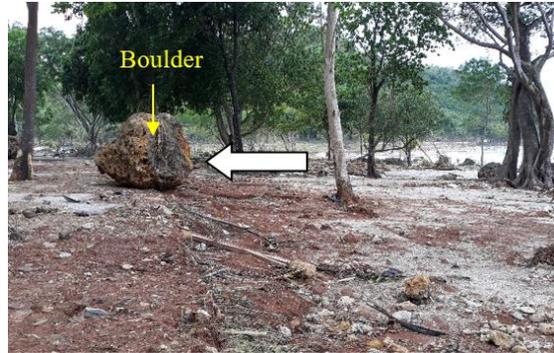
Figure 9. Boulder was dragged on land

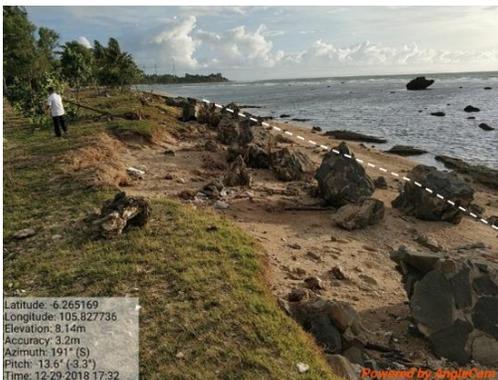
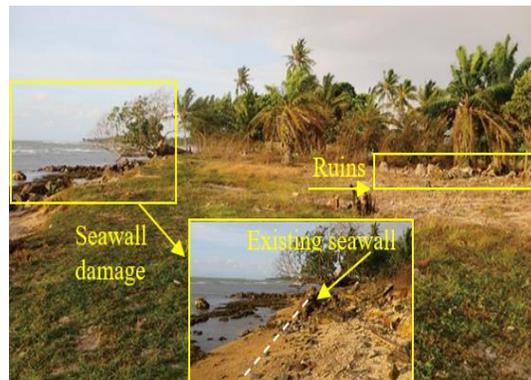
Along the Chery Beach location, a relatively long seawall was constructed, probably to protect the beach from erosion. The seawall was not very strong as it was only made of cemented stones. The seawall was almost completely destroyed by the tsunami. An example of the ruins is given in Figure 10. As can be seen in the figure that, no part of the wall survived (Figure 10(a)). The dotted line represents the approximate original location of the seawall. In fact, some of the ruins were swept and drifted away as debris. This type of debris is also very dangerous for people during the tsunami event where they tried to escape from tsunami. Some of the debris was drifted approximately 50 m away from the beach (Figure 10(b)). Tsunami inundation at this location is about 3 m judging from the marks left by tsunami and dried leave of the coconut tree.

Figure 10. Seawall damage in Chery Beach Banten

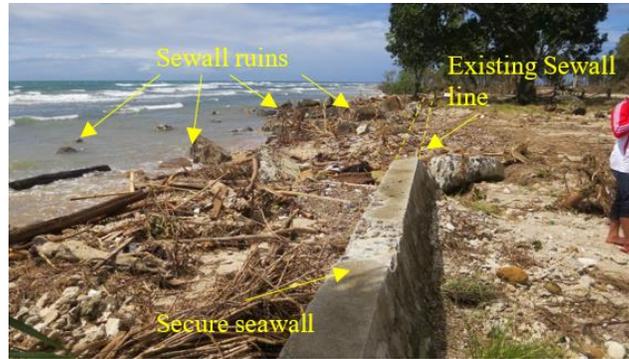
Another seawall in different location which is at Batu Hideung Beach (Figure 11) was also destroyed. This was a relatively new seawall construction. Similarly, the seawall was aimed at protecting the beach area from erosion. The depth of the foundations of both the Chery Beach and Batu Hideung are approximately 0.5 m.

Figure 11. Seawall damaged at Batu Hideung Beach Banten

Unlike the debris of seawall at Chery Beach, the ruins of Batu Hideung seawall were scattered at the seaside. There could have been a number of possibilities. First, the seawall was strong enough to withstand tsunami during run up due to the land support but, it was failed during the rundown time as no land support at the seaside. Second, there was a possibility that the area behind the seawall was inundated due to tsunami coming from adjacent location since the tsunami height along Sunda Strait varied considerably. For example, the inundation at Sukarame Beach were approximately 2 to 3 meters, however at TPI Sukanegara (fish auction) which is only 660 m to the north, there was almost no inundation on land. A witness whose house is near the fish auction explained that he could only saw that, the water of the river mouth (used as fishing boat harbor) was turbulence and that the boats were hitting each other very hardly. He confirmed that there was no significant inundation at that location. The rundown of the tsunami was probably the one that destroyed the seawall. This analysis is also supported by the fact that there is a hill at 120 m to 200 m (Figure 13) behind the seawall that could have reflected back the tsunami, increased the inundation depth behind the seawall and dragged the seawall and the ruins to the sea side. During the survey, the positions of the ruins were documented. The schematic positions of the original seawall and the ruins are given in Figure 12. The cross-section was measured along the original seawall position at every 4 m distance. The location of the seawall and the surrounding area are presented in Figure 13.

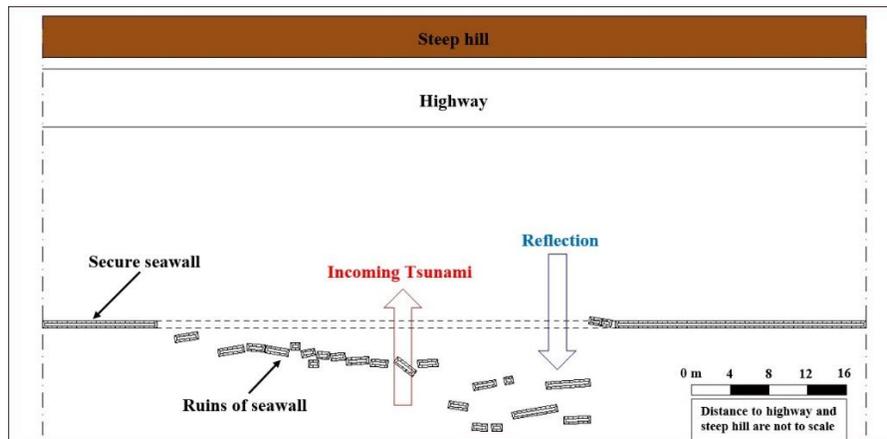
Figure 12. Schematic of seawall and ruins positions

As can be seen in Figure 12, the ruins of seawalls were found in front of the seawall original position at the beach side. It indicates that the debris were dragged seaward during tsunami run-down. In Figure 12, it can be seen that the debris were scattered with the longest distance of the debris from its original position was approximately 10 m. Actually, this is the preferred condition for a ruined seawall since, the dragging of debris seaward is expected not to harm anyone or buildings in the sea. Since seawalls are normally built along the coast to protect the beach from erosion, it is important to understand the failure mechanism which dictates the direction of the debris when the seawall is destroyed by tsunami.

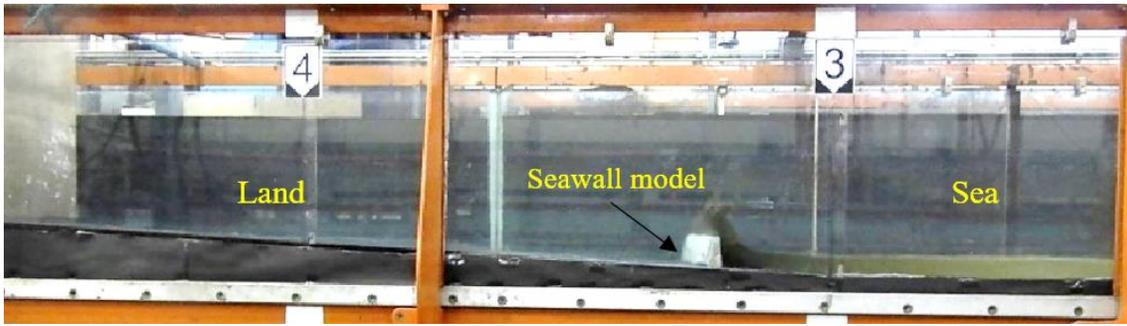
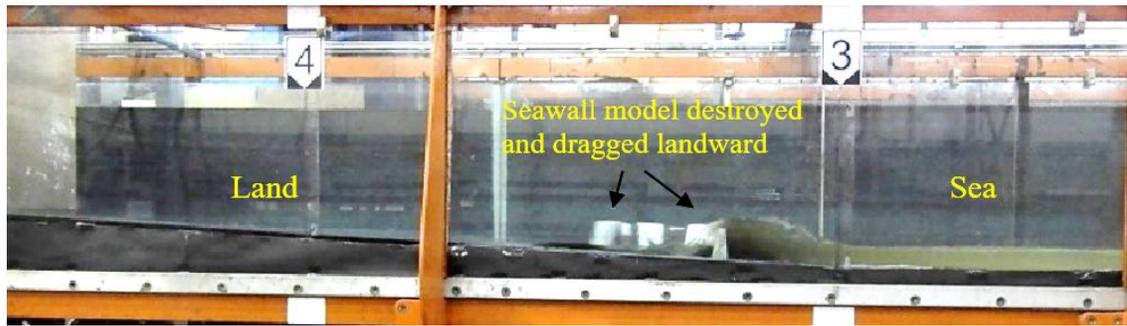
The experiment of the tsunami attack on seawall structure is presented in Figure 17. The first model was tested where the model was placed on top of the flume bed and no land support behind the wall. In this case, the seawall under the test would finally be damaged and was dragged landward. As can be seen in Figure 18, the broken seawall was dragged landward. The second model was tested where the seawall was supported by land of approximately 40% of the wall height (0.024 m). As indicated in Figure 19, the seawall was stable against the incoming tsunami. However, during run down, the seawall was destroyed and the debris was dragged seaward. Figure 19 shows the conditions of the seawall model after tsunami attack where the surge depth was 3.1 cm. It was the return flow or the run down that destroy the seawall. Hence the debris was dragged into the sea.

(a) The tsunami hit the seawall

(b) The seawall was damaged by tsunami

Figure 17. Simulation of seawall destruction due to tsunami

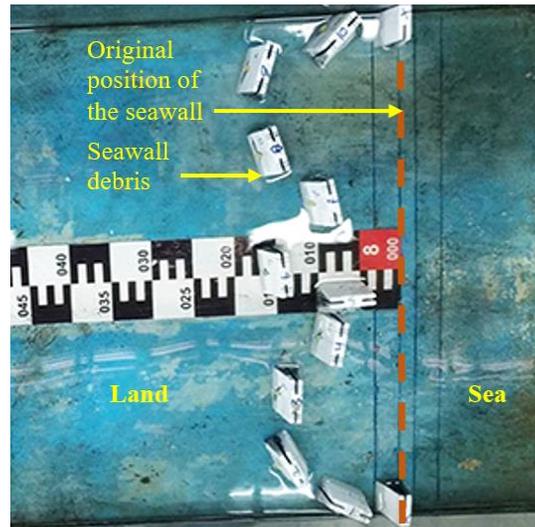
Figure 18. Debris of seawall were dragged landward, no land support behind the seawall

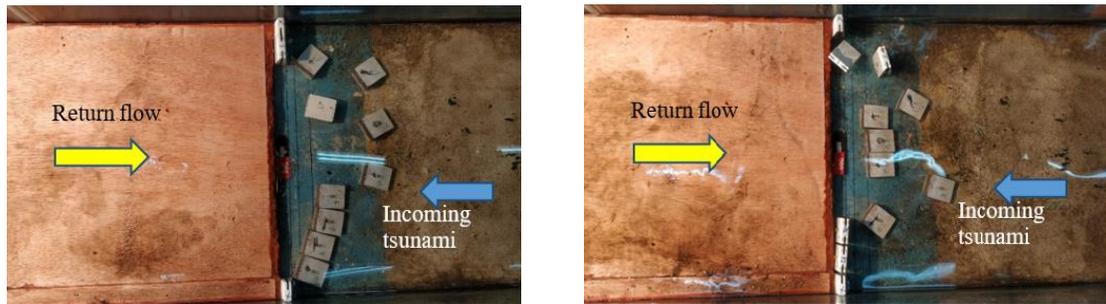
(a) Without wedges

(b) With wedges of 1.4 cm

Figure 19. Seawall condition after wave attack (with land support)
