## SCIENCE OF TSUNAMI HAZARDS

Volume 30

### THE 1990 BOHOL EARTHQUAKE: TSUNAMI OBSERVATIONS AND EFFECTS AT BOHOL ISLAND, PHILIPPINES

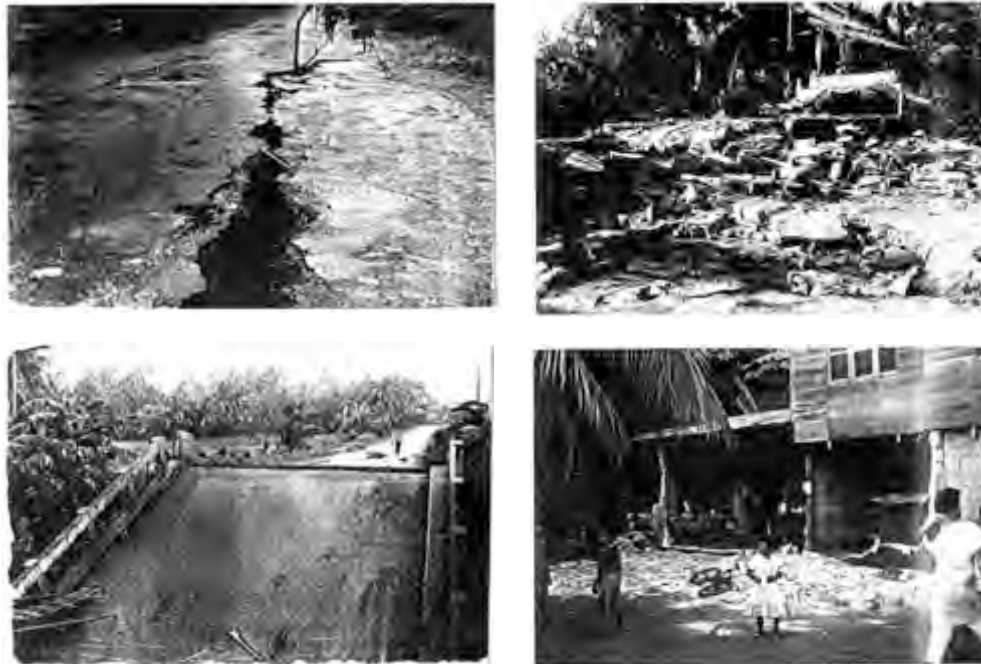
Based on eyewitness interviews, it was determined that the quake's shaking lasted for about 3-7 seconds. Along the southeastern shores of the island, strong ground motions, widespread ground fissuring, landslides, subsidence and mud fountaining were responsible for most of the significant damage to the infrastructure of municipalities. Reportedly, a bridge collapsed and roads were closed by rockfalls. Figure 4a shows some of the damage.

**Figure 4a:** Photos adapted from Umbal et al. (1990) showing the damages at Guindulman (A), fault rupture near Anas (B), the collapsed bridge at Alijauan bridge at Jagna (C) and collapsed house in Candabang, Anda (D).

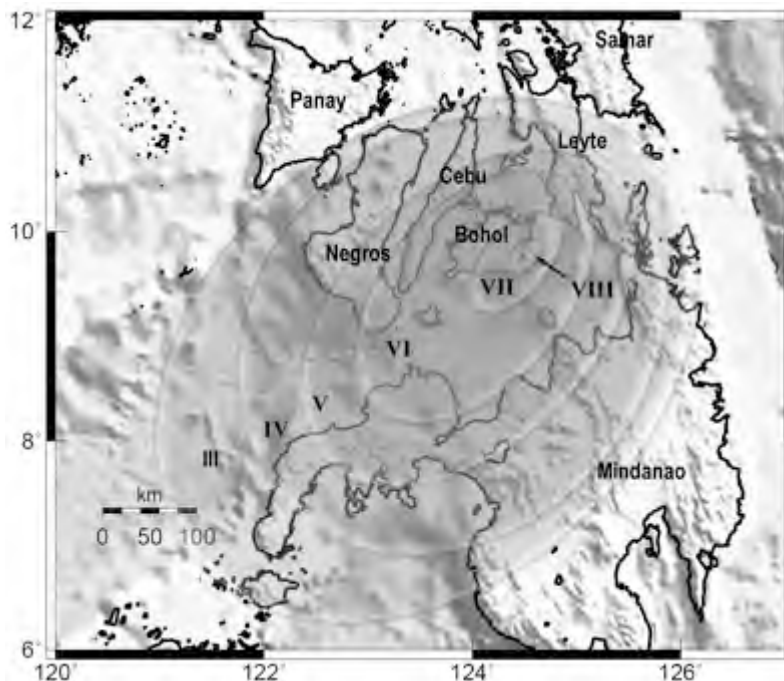
Remnants or repairs of century-old churches indicated the extent of severe ground shaking in numerous towns. Based on observations of ground shaking and the associated environmental damage, an isoseismal map was prepared (Figure 4b). High intensities with NE-SW orientation were concentrated along the southeastern part of the island. Mapped ground ruptures (Umbal et al., 1990) were located about 7 km south of the EBF (Figure 2) and west of the highest observed intensities.

**Figure 4b:** The earthquake intensity distribution of the 1990 Bohol earthquake based in this study and Umbal, et. al. (1990). Note the northeast-southwest elongation of the isoseismals.

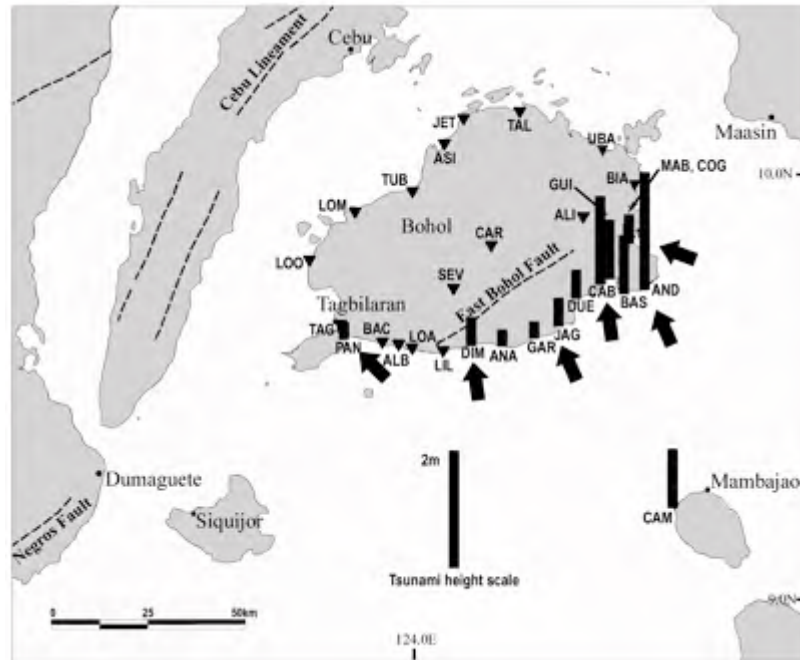
Evidently, the 1990 earthquake generated small to moderate tsunami waves which affected the SE portion of Bohol (Figure 5). The maximum runup height of 2.11m was measured at AND that extends to MAB in the northeast and to TAG in the southwest. Between DIM and PAN, there were only reports of the sea level lowering, but no unusual increase in wave height or tsunami inundation. The reported tsunami at PAN and TAG could probably be due to possible island trapping effect (Yeh et al., 1994; As-Salek, 1998). It is noted that most notable tsunami runup heights were concentrated along the southeastern portion of Bohol Island - including a report from Camiguin island (CAM) of

**Figure 5:** *Tsunami heights measured for the Bohol 1990 quake. Broad arrows indicate the observed direction of the incoming tsunami waves.*
