TSUNAMI IMPACTS ON MORPHOLOGY OF BEACHES ALONG SOUTH KERALA COAST, WEST COAST OF INDIA

ABSTRACT

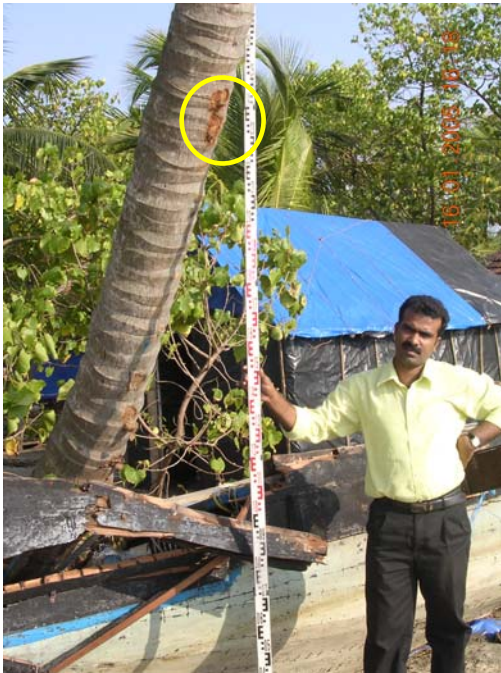
Fig. 4:
A photograph shows the run-up height of tsunami at Edavanakkadu.

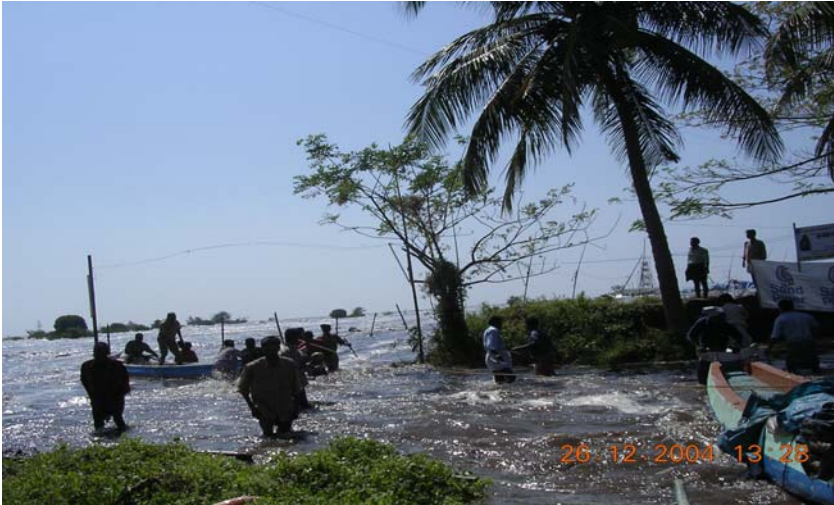
Fig. 6:
A photograph showing the tsunami inundation at Puthu-Vypeen

The northern side of Cochin inlet (Puthu-Vypeen) beach is wide and having an average elevation of 1.5-2.0m. Monthly beach profile measurements have been carried out in this region as a part of an ongoing programme. Maximum inundation occurred here at 13:28 on 26th December 2004 as recorded by the digital camera from the shoreline, and covered up to 600m towards the land (Fig. 6). The post tsunami beach profiles of four stations at distance of 1km apart (Fig. 7) show the changes in beach elevation and erosion that have taken place near the seaward end. It is evident from the observation that the eroded sediments from the seaward side have been carried further inland and got deposited near the benchmark. The presence of vegetation on the beach appears to have helped to reduce the intensity and thereby decreased the erosional characteristics of the incoming waves. Most of the vegetation is seen already were wiped off during the run-up of waves, or being destroyed due to high saline conditions in the soil.

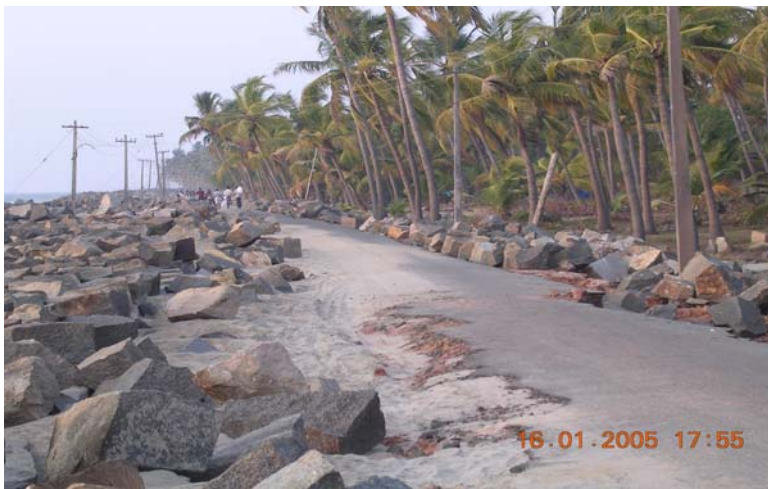
Fig. 9:
The destroyed and scattered seawall at Edavanakkadu

system is generally running parallel to the shoreline and the coastal areas are like a narrow strip of land (barrier Beach) lying between the backwater and sea. The inundated water had flooded into the backwaters and the force of wave has damaged most of the physical structures along the coast. It is evident that presence of seawall has played an important role in reducing the intensity of the waves along the coast, but the affected areas were not having any effective coastal defense structures (because the traditional fishermen use these places as fish landing centres). The tsunami floods at some places even destroyed the rubble-mound seawalls which got scattered along the coastline (Fig. 9).
