**EFFECTS OF THE DECEMBER 2004 TSUNAMI
AND DISASTER MANAGEMENT IN SOUTHERN THAILAND**

Chanchai Thanawood, Chao Yongchalermchai and Omthip Densrisereekul

Faculty of Natural Resources

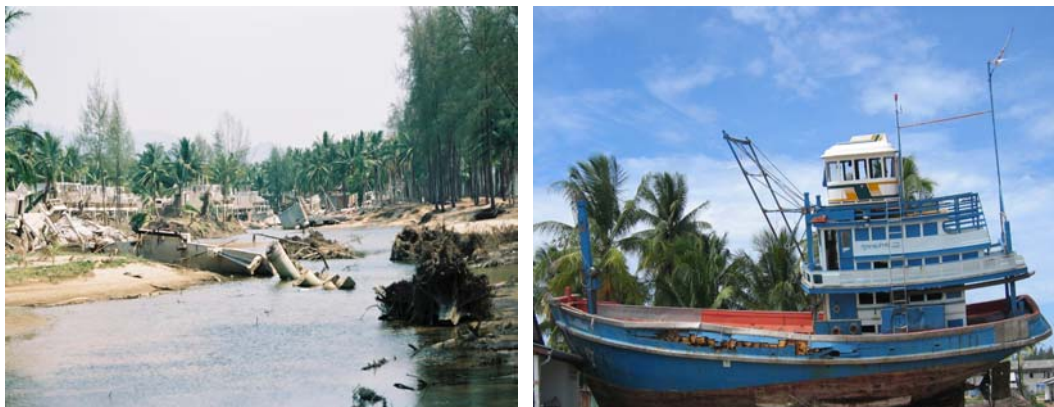
Figure 3 A group of resort buildings lies in ruins (left) and a fishing boat rests on shore (right).

communities, living in weakly-constructed houses near sea level, were completely wiped out and lost two-thirds of their inhabitants in the tsunami tragedy. The powerful wave washed away fishing boats and gear, destroyed culture ponds and damaged aquaculture infrastructure. A couple of large fishing boats were even thrown violently inland and deposited in a residential area of Ban Namkhem (Figure 3). At Pakarang Cape, Ban Bangkaya, the maximum tsunami run-up measuring up to 5-7 metres was observed. In this locality, intense beach erosion and severe damage to coral reefs and beach forests were observed (Figure 4), and almost all the luxury hotels and fisher folk villages in close proximity to the seashore lay in ruins. Agricultural land was salinated, and wells and ponds were contaminated with intruding sea water. The powerful wave also damaged coconut and oil palm plantations as trees were uprooted by the action of the wave. The ravages of the destructive wave extended up to 2 kilometers inland.

The tsunami wave of 10-12 metres and inland penetration of wave of 1 kilometres badly damaged Ban Bangnieng, which is one of the important tourist attractions south west of Pakarang Cape. Khao Lak beach, a newly constructed tourist spot, suffered a run-up height of 8-12 meters. The beachfront hotels, tourist resorts and tourism infrastructure along the shore were demolished. At this locality, approximately half of the 400 guests in a luxury beachfront resort perished in the ground-floor rooms, swamped by the force of the giant wave. The loss of life and damage to the property at Khao Lak beach was extensive because the beach was surrounded by elevated ground and hills. With run-up height of 5-6 metres, the tsunami also caused major loss of life and destruction of infrastructure to Khao Lak Merlin Resort. At this locality, the trail of destruction left by the devastating wave extended up to 1 kilometer inland.

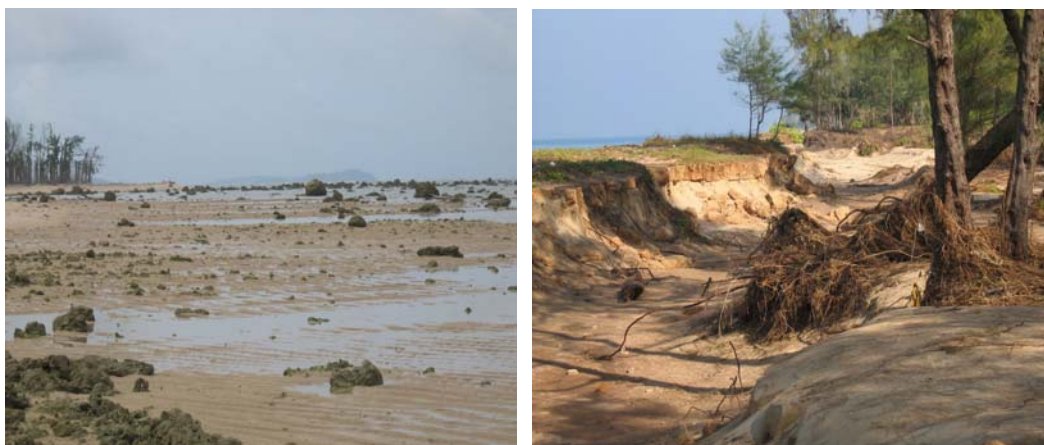
Figure 4 Views of the coastal shores in Takua Pa District after the 2004 tsunami.

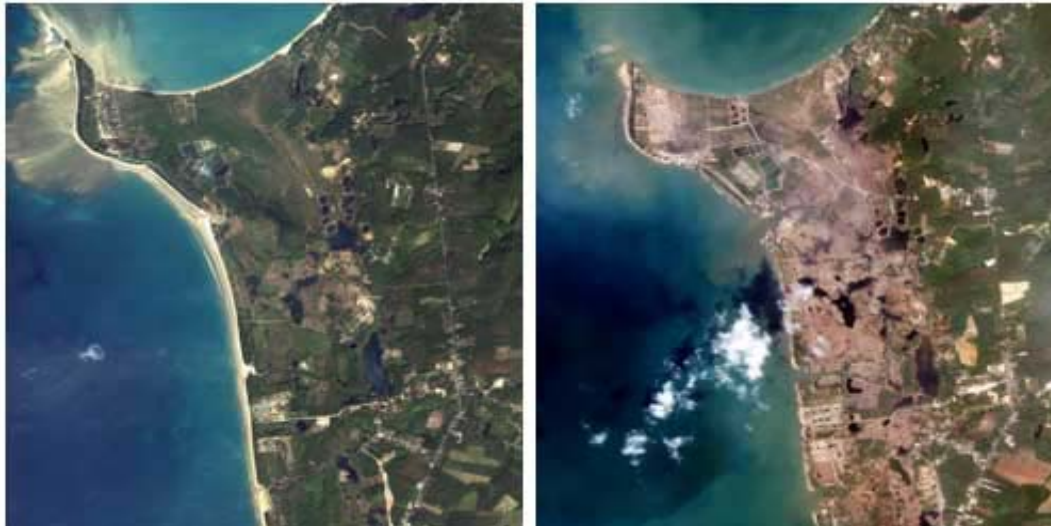
Figure 5. Pakarang Cape before (left) and after (right) the 2004 tsunami, showing beach erosion.

played an important role in mitigating the effects of the 2004 tsunami disaster (FAO, 2005). The catastrophe also caused significant geomorphologic changes along the Andaman coastline, such as eroding sand beaches and enlarging the mounts of the rivers to the sea (Figure 5). The devastating wave has in fact literally redrawn the shorelines of the Andaman coast of southern Thailand.

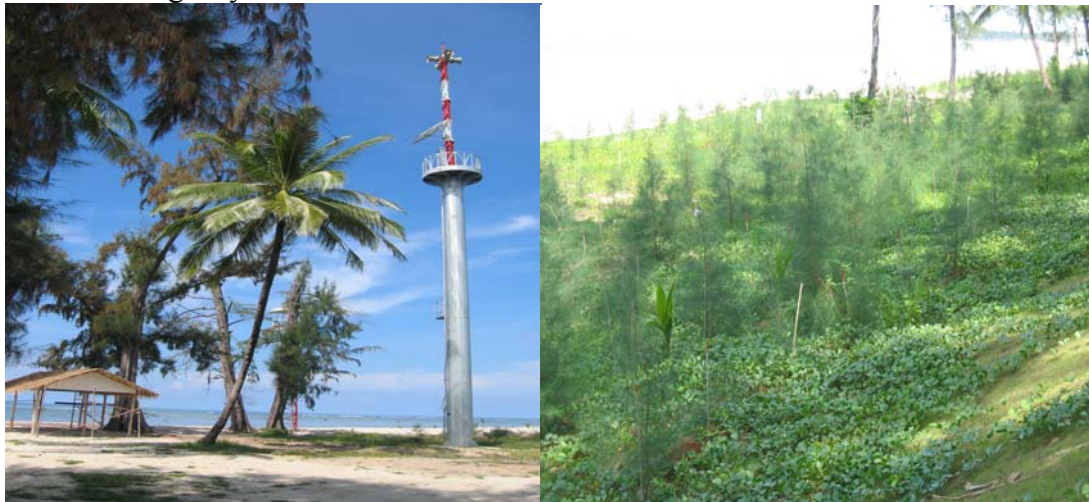
Figure 6 A tsunami warning tower (left) and re-planted beach forests (right) along the coastal shores.

1.3 Maintenance of environmental and ecological stability of the coastal areas through the enrichment of mangrove and beach forests to act as the first line of defense from tsunami waves (Figure 6), and rehabilitation of lost and degraded coral reefs and sea grass beds to help stabilize the coastline and prevent beach erosion.

2.1 Installation of a local tsunami warning system, which includes siren towers at popular and crowded beaches (Figure 6), and a tsunami warning sensor
