IMPACT OF TSUNAMI 2004 IN COASTAL VILLAGES OF NAGAPATTINAM DISTRICT, INDIA

ABSTRACT

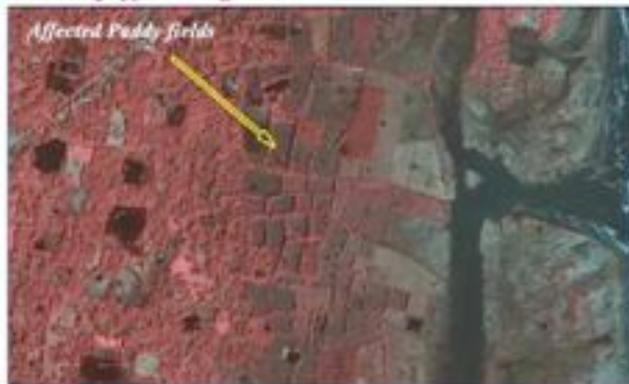
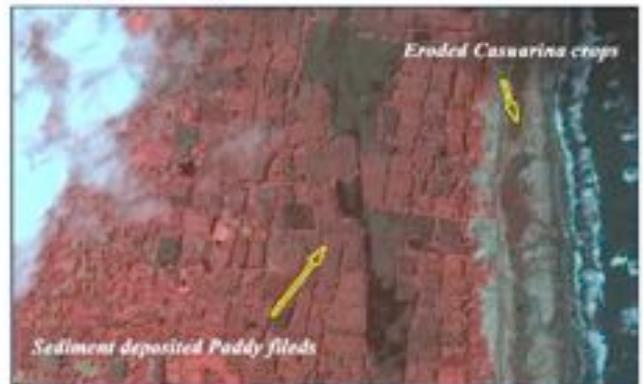
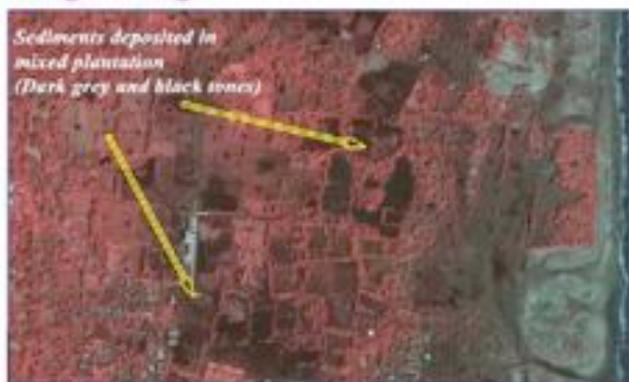
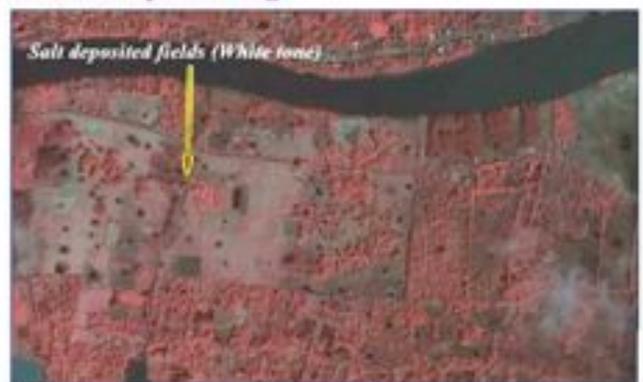
Figure 8. Impact of Tsunami on Agricultural and Horticultural lands in different villages of Nagapattinam and Kivalur Taluks Figure 9. Photographic views of Tsunami affected landforms and water bodies

Vadakkupoyyur village

Therkupoyyur village

Velanganni village

Pratabaramapuram village

The large extents of croplands were also affected by seawater intrusion. Paddy, casuarina and mixed plantation (cashew + mango + coconut + other crops) adjacent to the seacoast were the most affected agricultural and horticultural crops. With the action of sea waves, the lands were physically damaged by removal of soil by erosion and deposition of large amounts of sand and other debris. The canal, irrigation and drainage channels were damaged. In addition, the seawater intrusion led to development of soil salinity, damaging the crop as well as making the agricultural lands unsuitable for cultivation. Salinity developed in soil due to accumulation of soluble salts. Salt deposition in Seruthur and Pratabaramapuram villages are clearly visible in the imagery. As seawater contains considerable quantities of sodium salts, its intrusion creates soil salinity.

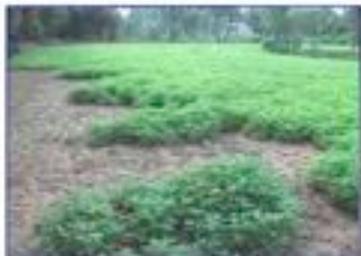
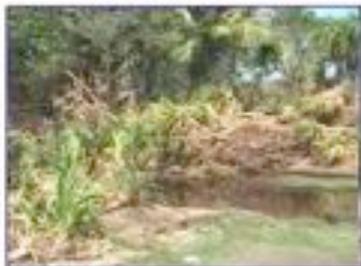
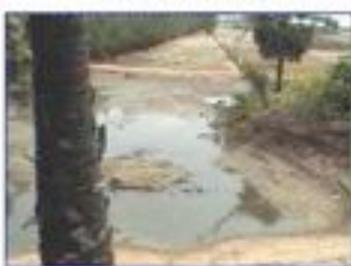
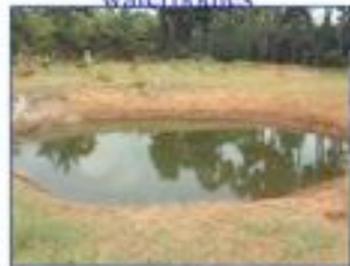
Figure 9. Photographic views of Tsunami affected landforms and waterbodies

Coconut & Mango

Channels

Waterlogging

Contaminated surface waterbodies

The harbor wave affected the agricultural and horticultural croplands by means of seawater intrusion. The invasion and receding action of harbor waves lead to the removal of soil by erosion and deposition of large amounts of sand, salt and other debris. The results on land use and land cover change detection studies revealed that the total of 747.91 ha of agricultural and horticultural croplands were affected by Tsunami, which includes paddy (610.52 ha), mixed plantation (67.04 ha) and casuarina (137.39 ha). Paddy fields were affected by erosion, salt deposition, water logging and other deposited sediment and the extent of area affected are 52.71 ha, 101.97 ha, 116.08 ha and 43.75 ha respectively. The widening of canals, tanks and newly formed brackish water channels occupied an area of 296.01 ha in paddy fields (Table 3) (Fig.10). The land use of mixed plantation (before Tsunami) was affected by soil erosion (8.76 ha), water logging (2.95 ha), salt deposition (19.24 ha) and other sediment deposition (34.85 ha). In case of casuarina fields soil erosion, water logging, salt and sediment deposition registered an area of 54.63 ha, 3.68 ha, 8.55 ha and 3.49 ha respectively.

The intrusion and receding action of the waves caused widening of canals in some parts of the study area. Deposition of sand particles in canal and water body occupied an area of 39.65 hectares. Tsunami has also caused land cover changes in sea, sand dune and saltpan areas. The receding action of waves led to deposition of eroded sand particles into the sea and thereby 11.27 ha of sea area were occupied by sand. Similarly, in some parts of the study area the intruded seawater did not recede back and it occupied an area of 2.86 ha. In Nagapattinam district, there are dense households from the coast up to 1.5 km. Tsunami has damaged the settlement area to an extent of 138.98 hectares. The study was carried out in Tsunami affected villages of Nagapattinam district to know about the impact on soil and water qualities. During January, February and March 2005, the Nagapattinam district received a rainfall of 6.6 mm, 326 mm and 120 mm, respectively. So, the effect of summer rainfall on soil and water qualities was also studied.

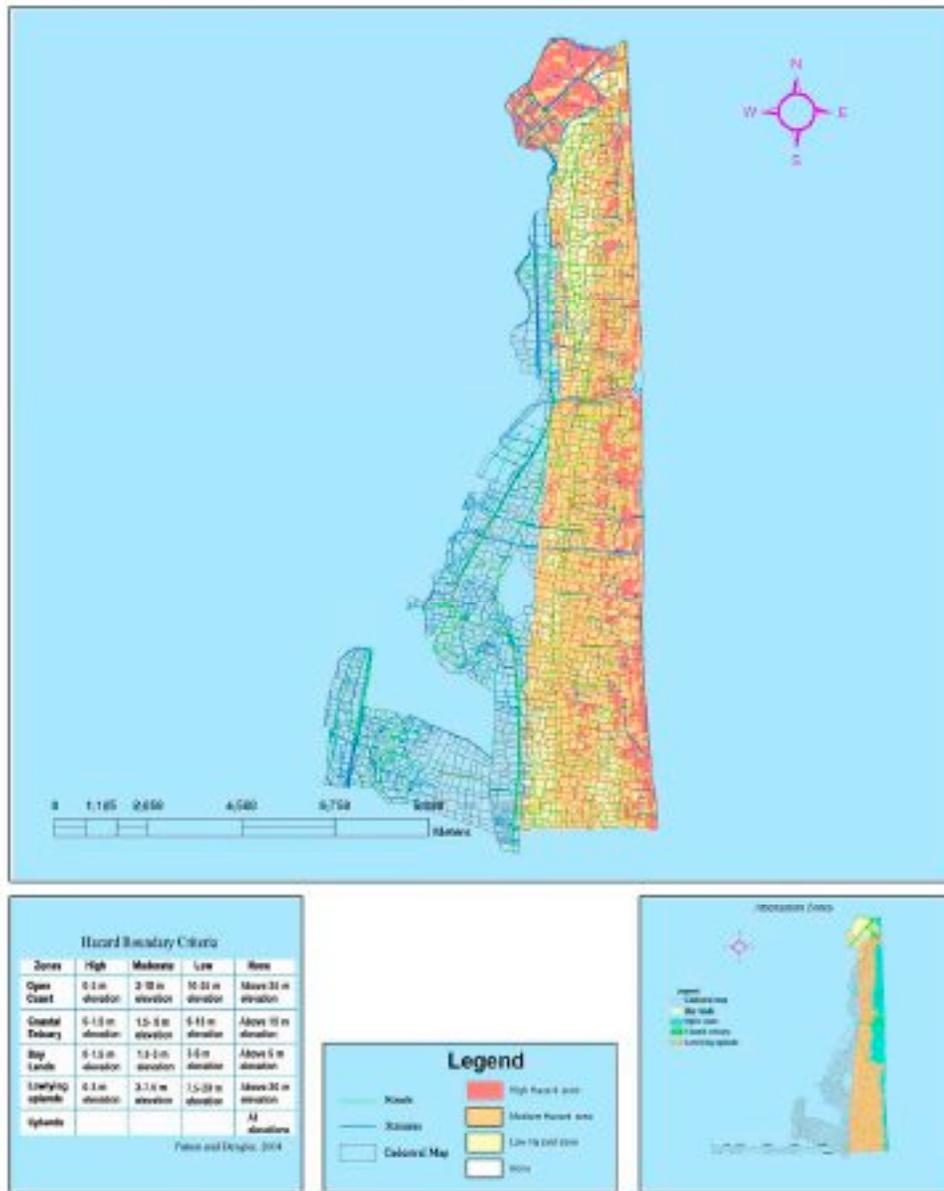
Figure 11. Tsunami Hazard Map generated using GIS approach

Tsunami hazard maps are generated using a geographical information systems (GIS) approach for coastal Nagapattinam. Hazard maps are displayed as a continuous gradational color scale ranging from high hazard through medium, low to no hazard (Fig. 11). Hazard maps shows 20.6 per cent, 63.7 per cent and 15.2 per cent of the study area are coming under high hazard, medium hazard and low hazard category respectively (Table 6). The remaining percent shows no hazard to Tsunami.

In this study, the main focus was to generate hazard mapping to quantify the extent of the area prone to Tsunami. The criteria taken into consideration for assessment of hazard mapping were types of land adjoining the coast and the topographical difference pertaining to the land. These maps are GIS based to facilitate ready adaptation

by planners and emergency managers. The maps are intended for educational purposes, to improve awareness of Tsunami hazards and to encourage emergency planning efforts of local and regional organizations by illustrating the range of possible Tsunami events. Criteria boundaries defined by Patton and Dengler (2004) were adopted to delineate the regions and it has to be refined by comparing with the Tsunami events. Factors like Tsunami strength and its character were not considered in the hazard mapping.
