**DESIGN LOAD EVALUATION FOR TSUNAMI SHELTERS BASED ON DAMAGE
OBSERVATIONS AFTER INDIAN OCEAN TSUNAMI DISASTER DUE TO THE 2004
SUMATRA EARTHQUAKE**

Y. Nakano

ABSTRACT

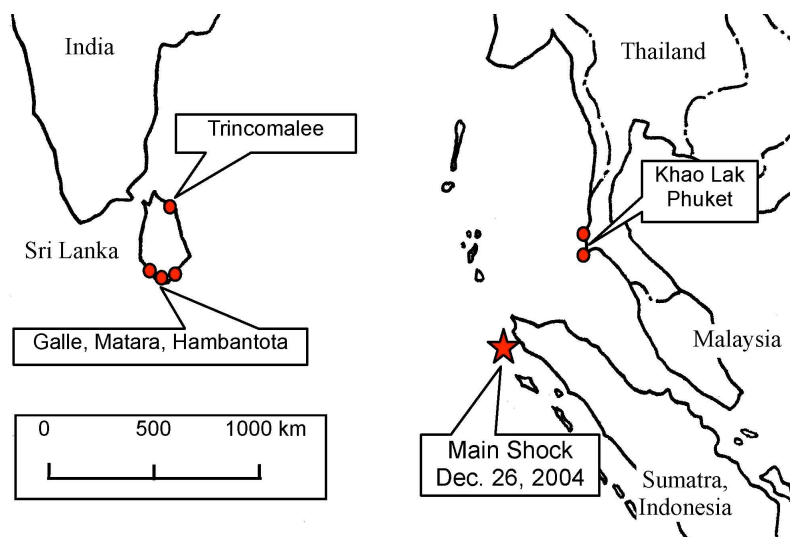
Figure 1 Epicenter and investigated areas

Damage surveys were made in (1) the northeast and south of Sri Lanka (Trincomalee, Galle, Matara, Hambantota etc.) on February 19 through 26, 2005 and (2) Phuket Island and Khao Lak of Thailand on March 9 through 13, 2005. Figure 1 shows the epicenter and surveyed areas. They are located about 1600 km and 500 km away from the epicenter, respectively, and have been little affected by ground shaking (Nakano 2007).

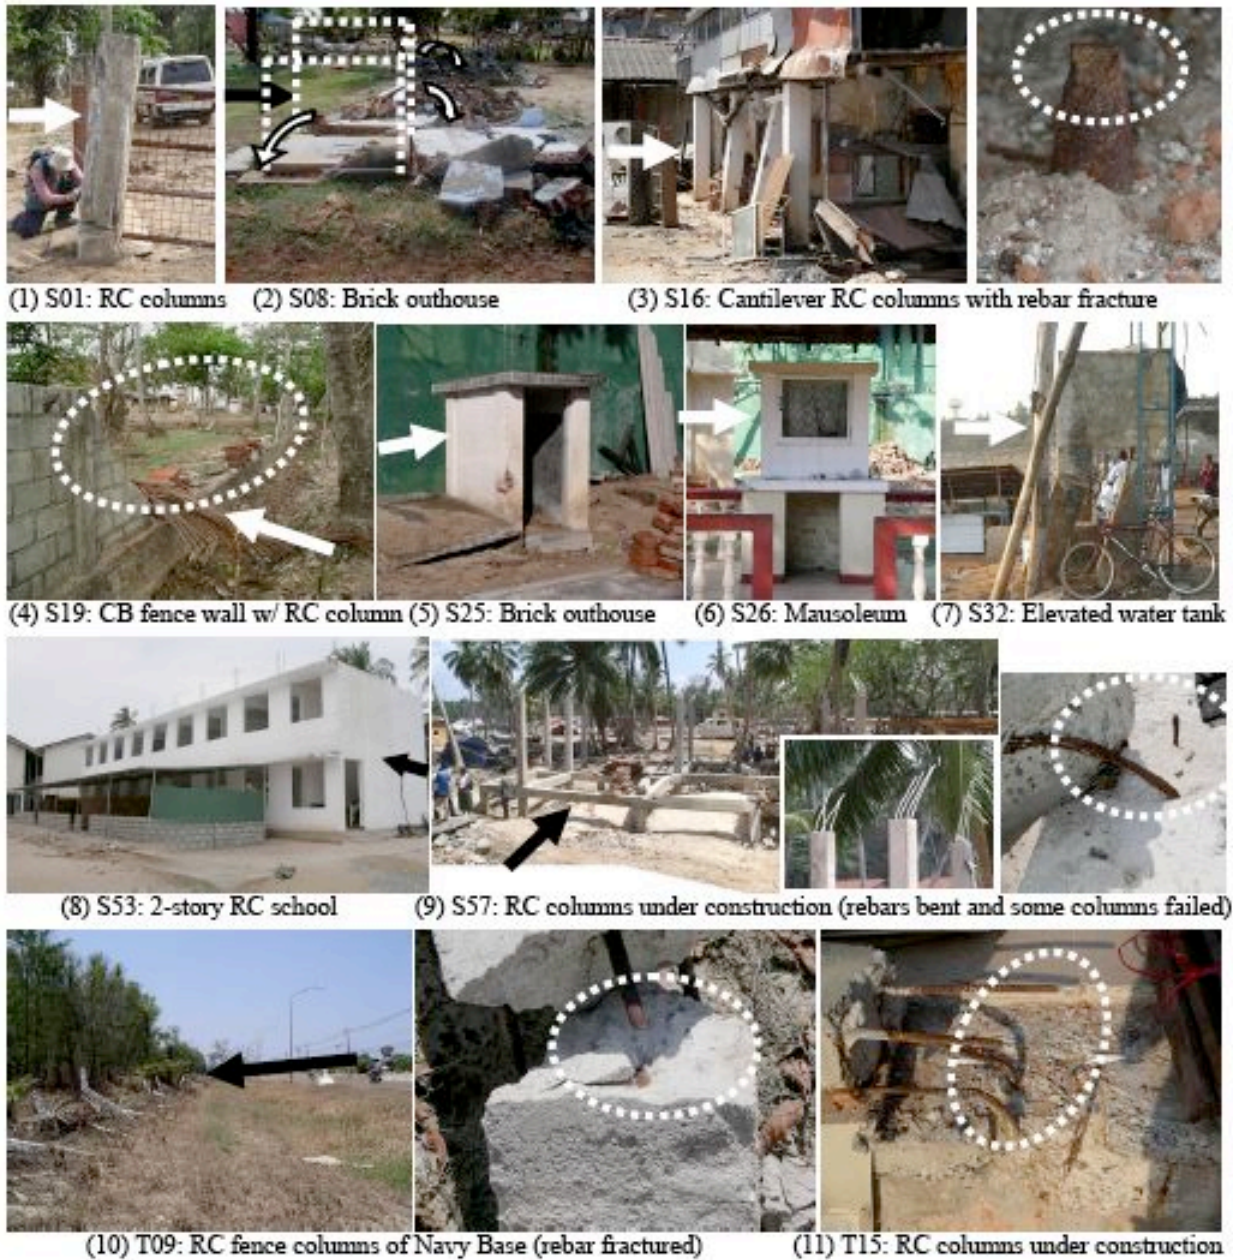
Photo 1 Typical damage to investigated structures ("S01" etc: ID Nos. in Table 1, "→": tsunami flow direction)

Table 1 summarizes the investigated structures and photo 1 shows their typical damage patterns. Note that the structures categorized in (d) through (f) described above were generally found in the affected areas in Sri Lanka, and their data were collected to identify the criteria between damaged and survived structures even if they had minor or no damage. Detailed damage descriptions of surveyed structures and their structural information can be found in the related report (Nakano 2005).

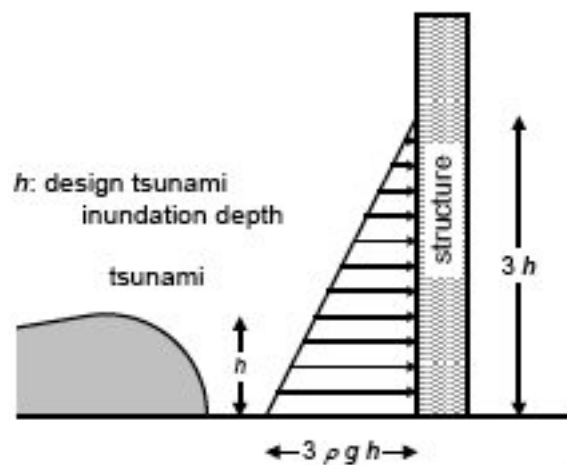
Figure 2 illustrates the background concept employed in Eq. (4.1). The design tsunami pressure distribution acting along the structure's height is assumed a triangular shape with the height reaching 3 times of the design tsunami inundation depth h (i.e., the pressure at the bottom is assumed 3 times of the hydrostatic pressure), which is based on the laboratory tests of 2-dimensional scaled model (Asakura et al., 2000). To examine whether or not the coefficient 3 in Eq. (4.1) is appropriate to evaluate the tsunami load, Eq. (4.2) is introduced in the manner analogous to Eq. (4.1). If the coefficient a successfully categorizes damaged and survived structures at its value of 3, one can say that Eq. (4.1) with a equal to 3 is a rational design formula to compute the tsunami load effect. In calculating the coefficient a , two typical cases of inundation depth and structure's height, which can be found in the guidelines (JCO 2005), are taken into consideration as shown in Figure 3 since they are the basic patterns of tsunami attack to existing structures in the surveyed areas.

Figure 2 Design pressure tsunami distribution (JCO 2005)

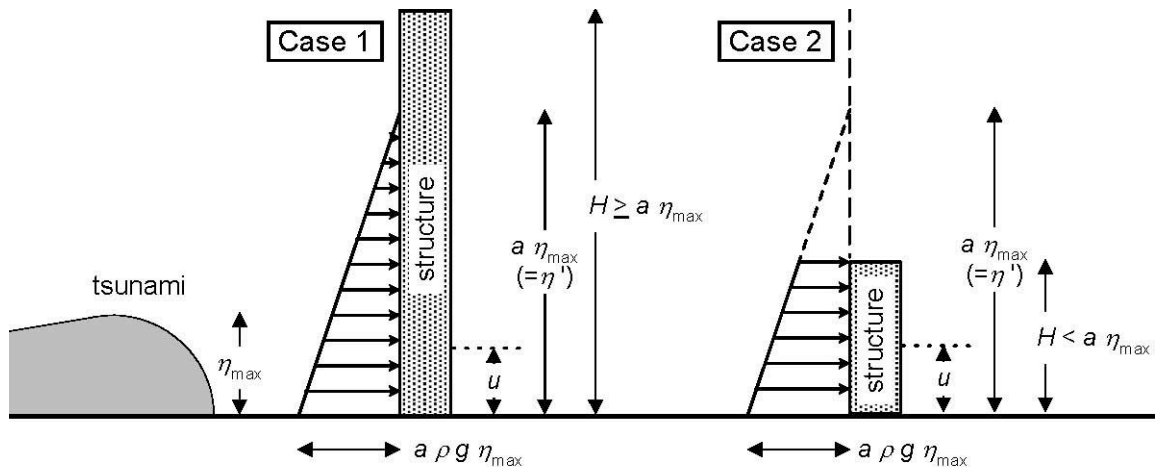
Figure 3 Tsunami inundation depth η_{\max} , building height H , and tsunami pressure distribution p_x (Nakano 2007)

1. Compute the lateral resistance of investigated structures considering their failure mode as shown earlier in Section 3.
2. Then compute shear force or bending moment acting at the failure point u (defined as the distance between the failure point and the ground surface) assuming the tsunami pressure distribution as defined in Eq. (4.2). Setting the force or moment at the height u equal to the lateral resistance obtained in step 1. above, evaluate the equivalent water depth η' corresponding to the resistance. Note that the tsunami pressure above structures is neglected and the depth η' is evaluated assuming the trapezoidal instead of triangular pressure distribution in computing the force or moment as shown in case 2 of Figure 3.

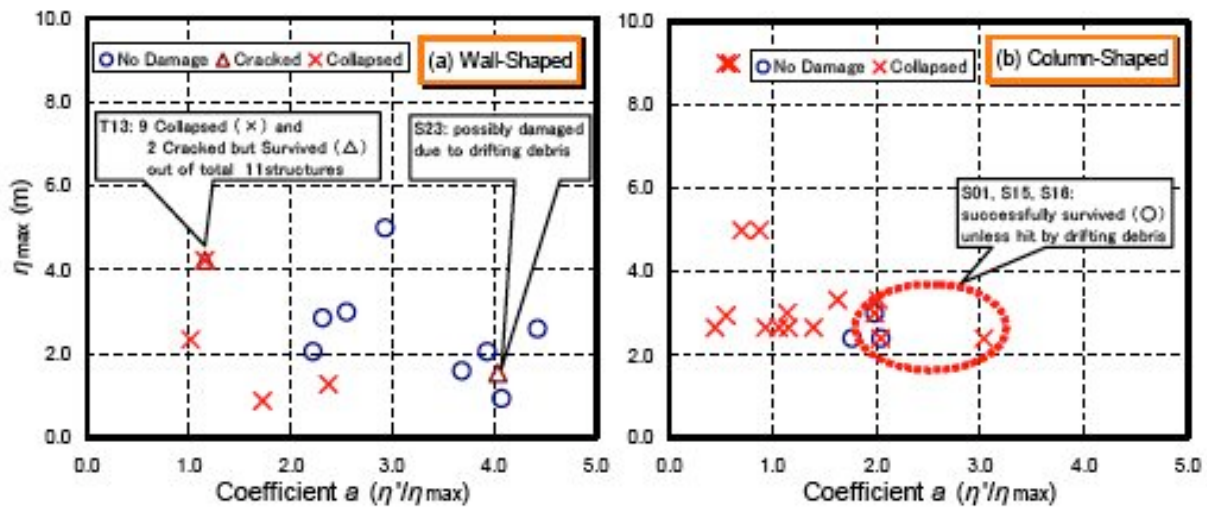
Table 1 shows the investigated tsunami inundation depth η_{\max} and the computed coefficient a . Their relationship is shown in Figure 4(a) for wall-shaped structures such as fence walls and in Figure 4(b) for column-shaped structures such as cantilever RC columns, respectively, where the structure type is determined based on the shape of member on which the tsunami attacks. When the structures with identical structural properties have different failure patterns due to the effects of drifting debris or some other reasons, two marks corresponding to different failure patterns are plotted at the same point of the figure.

Figure 4 Computed Coefficient a vs. observed tsunami inundation depth η_{max} (Numerals in the figure denote ID Nos. in Table 1)

Figure 4(a) shows that structures with the value of a greater than 2.5 have no major damage except for the case S23 that may have been damaged due to drifting debris, and the value of 3 for the coefficient a proposed in the guidelines can be considered rational to avoid serious damage due to tsunami attack. It should be noted, however, that the structure (S23) having the coefficient a greater than 4 suffers wall cracking, and the coefficient of 3 may not be conservative if the load amplification due to drifting debris is taken into account, and countermeasures to protect structures from damage due to drifting debris need to be taken.

Figure 4(b) shows that the coefficient a for column-shaped structures to discriminate between damaged and survived may lie at around 2 when the effects of drifting debris are neglected, which is slightly lower than that for wall-shaped structures. This result implies that column-shaped structures have advantage in tsunami resisting performance over wall-shaped structures on condition that both structures have enough seismic capacity to survive the ground shaking prior to the tsunami attack. It should also be noted, however, that the column-shaped structures can not be left undamaged at the coefficient a in the range of 2 to 3 as shown for the cases of S01, S15, and S16, and countermeasures against drifting debris need to be taken to protect structures as is the case of wall-shaped structures previously described
