**IMPACT OF TSUNAMI FORCES ON STRUCTURES  
The University of Ottawa Experience****D. Palermo, I. Nistor & T. Al-Faesly**  
*University of Ottawa, Ottawa, Canada***A. Cornett**  
*National Research Council, Ottawa, Canada***ABSTRACT**

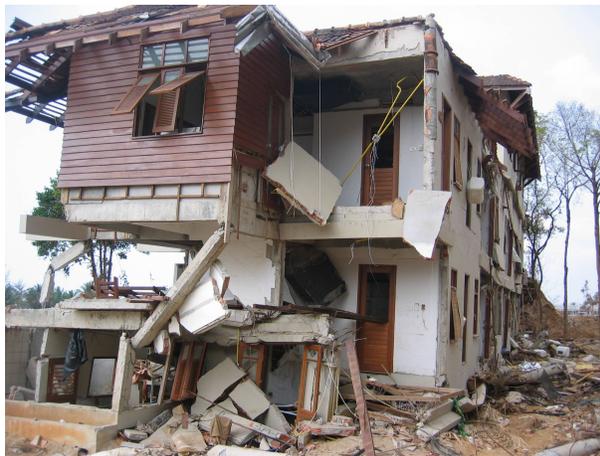
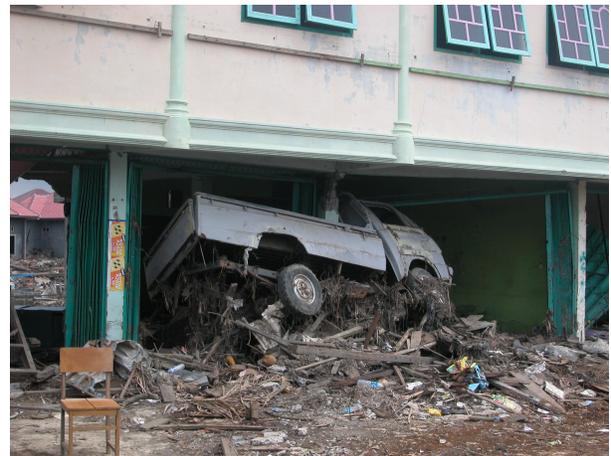
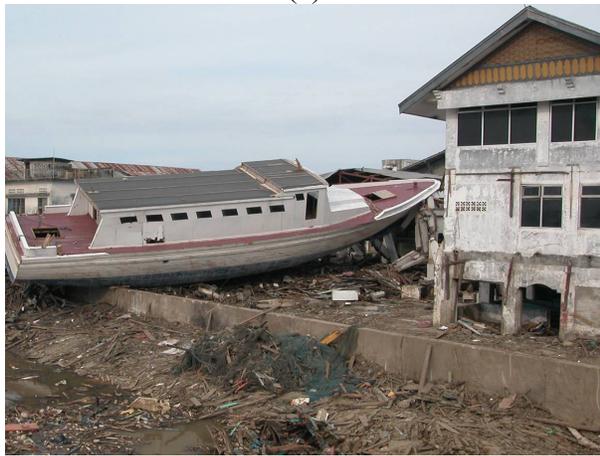
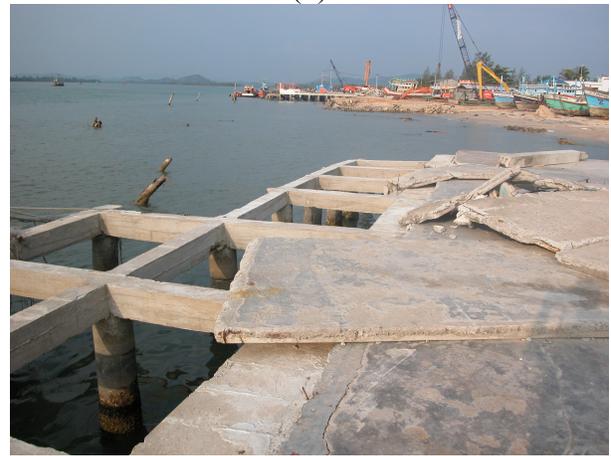
Figure 1. Effects of 2004 Indian Ocean tsunami on structures (Saatcioglu et al., 2006a, 2006b): a) global damage to non-engineered concrete residential structure in Phuket Island, Thailand; b) debris impact and damming in Banda Aceh, Indonesia; c) debris impact from large vessels in Banda Aceh, Indonesia; and d) uplift of concrete slabs in Khao Lak, Thailand.

The 26 December 2004 Indian Ocean tsunami marks a significant historical event. Researchers and engineers became more attentive to tsunami hazard as a result of the significant damage to many coastal communities and the massive human casualties that was experienced across the Indian Ocean. Prior to this event, with the exception of a limited number of shelter-type structures, tsunamis were not considered in the design of inland structures located within inundation zones. It was also a “wake-up” call for other regions of the world located near subduction zones, particularly those located around the “Pacific Ring of Fire”. The Indian Ocean tsunami was triggered by a 9.1 magnitude (Richter scale) earthquake along the northwestern coast of the Indonesian island of Sumatra. The earthquake focal depth for this event was approximately 30 km. The main fault rupture zone was approximately 90 km wide and 1200 km long. A maximum tsunami run-up of approximately 51 m was observed in Indonesia (NGDC, 2012). From a structural engineering perspective, significant lessons were learnt, such as the types of loading that are generated during a tsunami event and the vulnerability of non-engineered structures. Fig. 1 (a) highlights the global damage suffered by non-engineered residential structures due to the advancing tsunami flow. Figs. 1 (b) and (c) depict the large objects that were transported by the tsunami, which resulted in significant impact loading on structural components. Fig. 1 (d) captures the uplift and displacement of concrete dock slabs due to the rapidly rising tsunami.

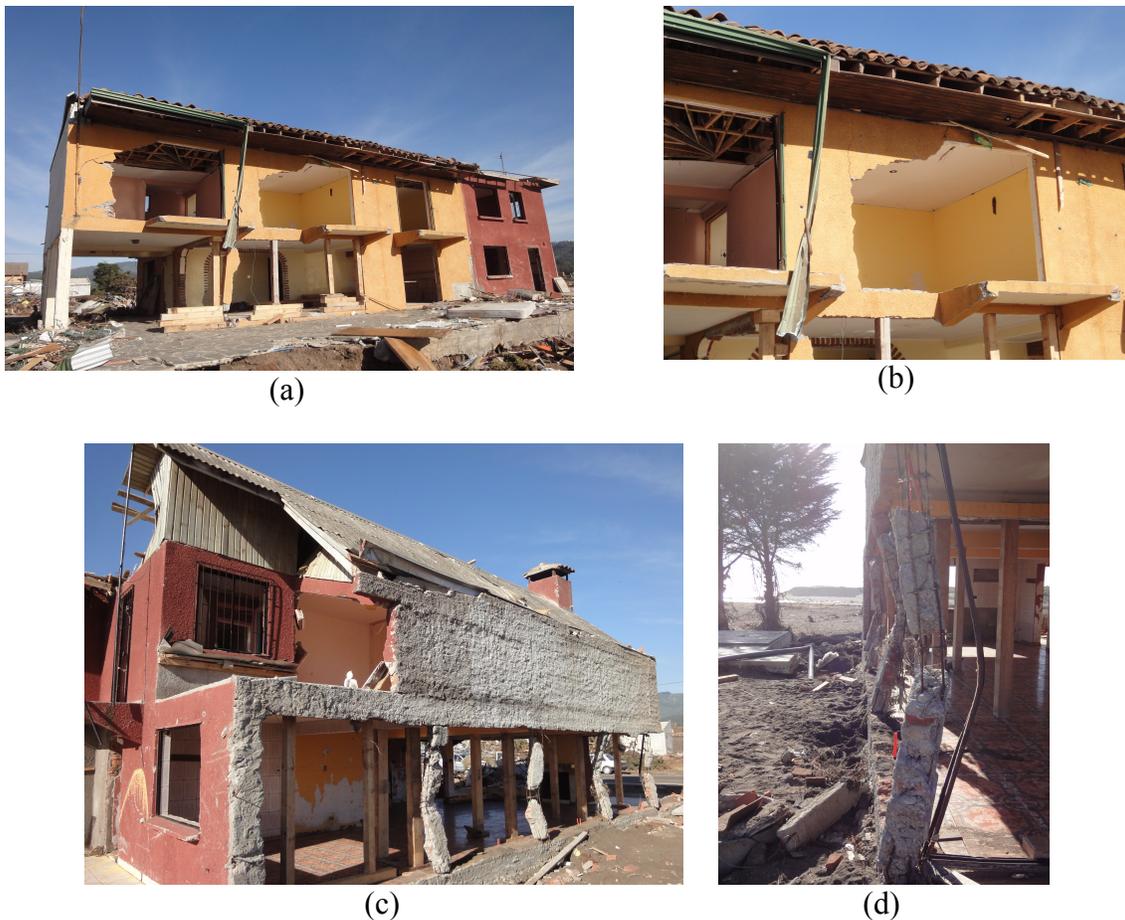
Figure 2. Effects of 2010 Chile tsunami on residential structures in Pelluhue (Palermo et al., 2013): a) global damage to two storey-structure; b) punching failure of second storey masonry infill walls; c) damage to masonry infill walls and loss of load bearing elements at first storey level; and d) destruction of lower level columns.

localized runup of 29 m on a coastal bluff at Constitución. The maximum inundation distance of approximately 1032 m was observed in Playa Purema. While many coastal communities suffered widespread damage, the number of casualties attributed to the tsunami was low. According to the International Tsunami Information Center, approximately 124 deaths were attributed to the tsunami. This was a direct result of two factors. First, Chile had experienced a major tsunami in 1960, which remains engrained in the memory of the local population. The 1960 event was triggered by a 9.5 magnitude earthquake, and approximately 1000 deaths were directly attributed to the tsunami. The highest wave height was 25 m at Isla Mocha (Dunbar et al. 2010). For the 2010 tsunami, in general, those living along the coast immediately searched for higher ground upon experiencing the ground shaking caused by the earthquake. Second, the central coastline of Chile is in close proximity to higher ground providing a natural vertical evacuation. Fig. 2 illustrates damage sustained by residential dwellings in the coastal community of Pelluhue. The photos reveal that the homes were fully inundated by the tsunami.

The residential structure in Fig. 2 (a) suffered punching failure of the infill masonry walls at the second storey level and failure of the lower level bearing elements. Timber columns were used at the lower level as temporary vertical supports. The residence in Fig. 2 (c) also sustained complete failure of the lower level columns, and temporary timber columns were used to support the upper level.

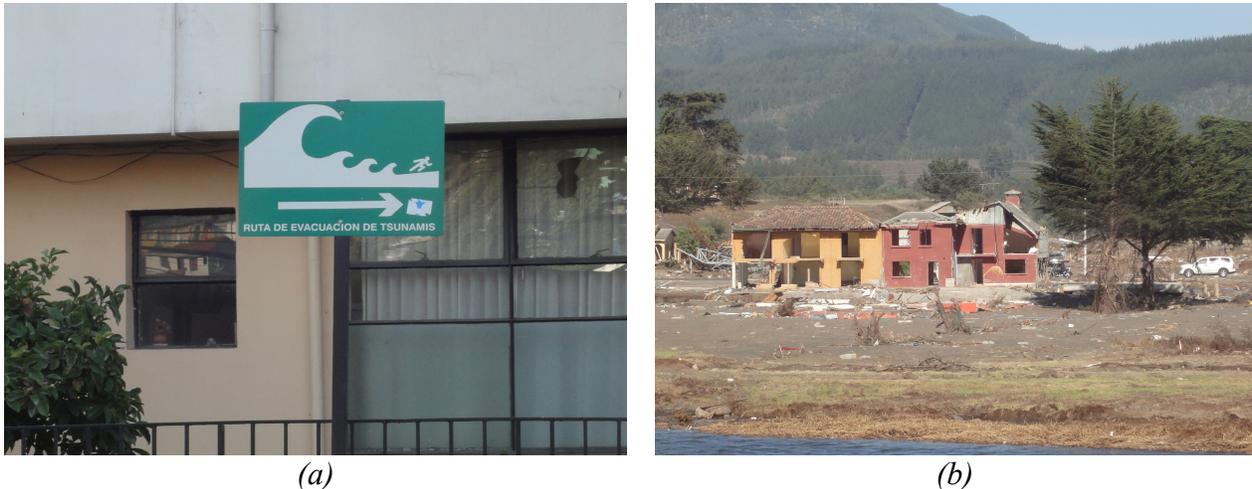
Figure 3. Evacuation: a) tsunami evacuation route directions in Tome, Chile (Palermo et al., 2013); and b) higher ground in Pelluhue, Chile

Fig. 3 (a) shows signage that was evident in Tome to direct people away from the inundation area and to safe higher ground, while Fig. 3 (b) is a photo depicting the higher ground that is within the coastal region that is typical of many communities in Chile.

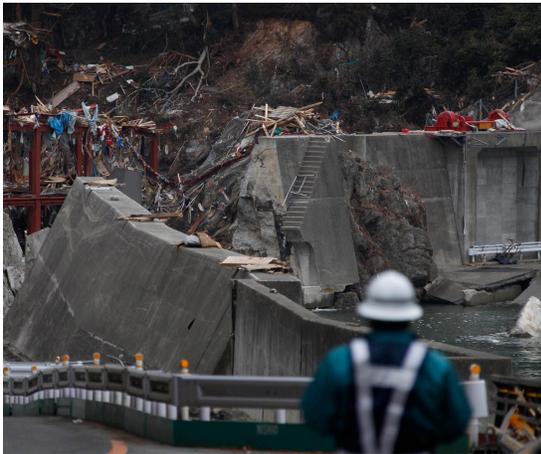
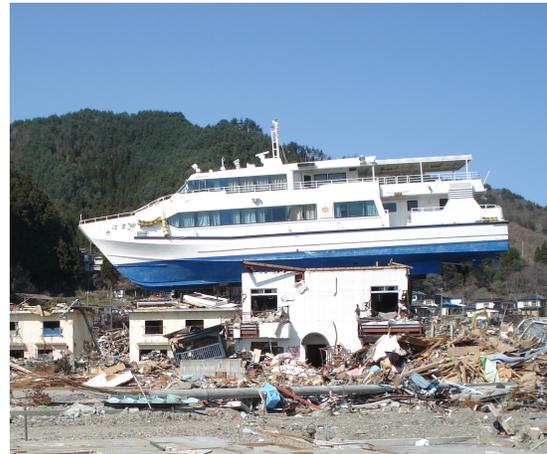
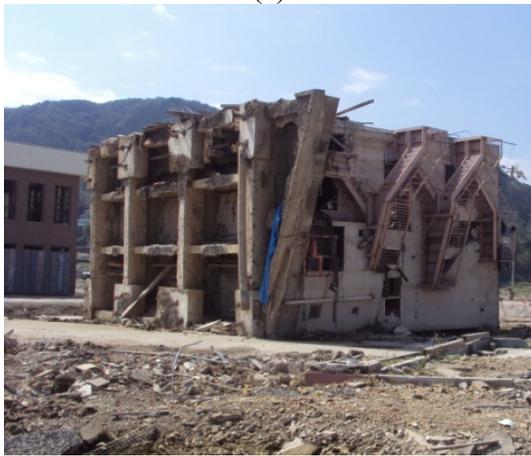
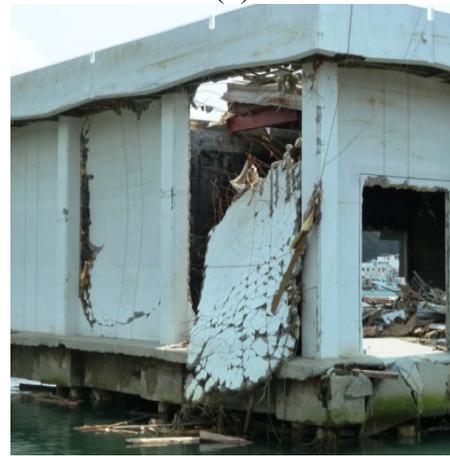
Figure 4. Effects of 2011 Japan tsunami on structures (Nistor, 2012): a) breaching and overtopping of concrete sea walls in Taro; b) impact loading from large vessel in Otsuchi; c) overturning of reinforced concrete apartment building in Onagawa; and d) punching failure of reinforced concrete walls in Onagawa

A powerful earthquake of magnitude 9.0 (Richer scale) occurred at a depth of 30 km under the Pacific Ocean, near the northeast coast of Japan. The epicenter of the earthquake was located approximately 129 km east of Sendai, Honshu, and the subsequent tsunami arrived on the northeastern coast of Japan approximately 15 minutes thereafter, leaving little warning time for many villages and communities. Local run-up heights of up to 48 m were estimated (Chock et al. 2012). This event was responsible for approximately 15 867 deaths, 6 109 injuries, and 2 909 people missing. The Japanese Cabinet Office estimated direct losses of more than \$309 billion due to damage to housing, roads, utilities, and businesses, making it the most expensive natural disaster on record. The destruction caused by this tsunami was surprising. Japan is a leading country when it comes to protection against tsunami; however, the tsunami waves displaced, overtopped and destroyed large structures, such as seawalls, which were initially constructed to mitigate the impact of tsunami waves on local communities. The designs of these structures were based on historical tsunamis and were not necessarily sufficient considering probabilistic-based tsunami events. Fig. 4 illustrates the effects of the tsunami, including breaching and overtopping of large concrete sea walls, floating vessels, overturning of a concrete building, and punching failure of a reinforced concrete wall panel.

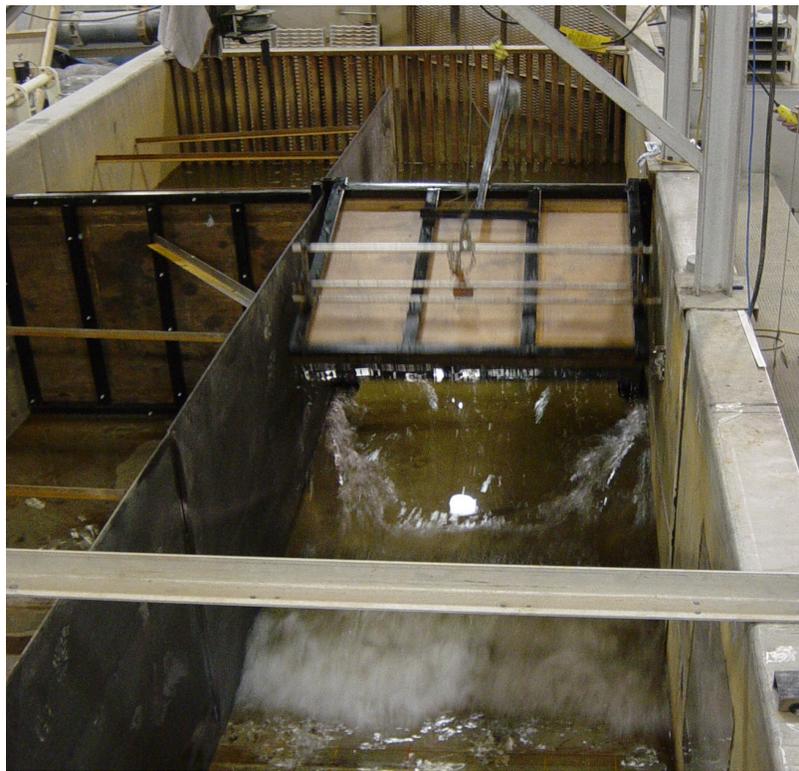
Figure 5. Turbulent hydraulic bore generated in the high discharge flume at the Canadian Hydraulics Centre

hydraulic bores that are representative of the tsunami-induced bores generated in many of the areas affected by tsunami inundation during the 2004 Indian Ocean, 2010 Chile and 2011 Japan tsunamis. This was achieved by partitioning a pre-existing open channel high discharge flume at CHC and installing a swinging hinged gate. The gate was installed near the upstream end of a 1.3 m wide by 7.3 m long channel, and was capable of impounding water in the closed position. The gate is able to open rapidly, releasing a turbulent hydraulic bore that travels downstream and impacts structural models (Nouri et al., 2010). This mechanism is similar to a dam-break phenomenon. Chanson (2005) demonstrated that dam-break flows could provide a reasonable simulation of tsunami-induced turbulent hydraulic bores. Fig. 5 is a photo of the high discharge flume with the gate in the open position producing a turbulent hydraulic bore.

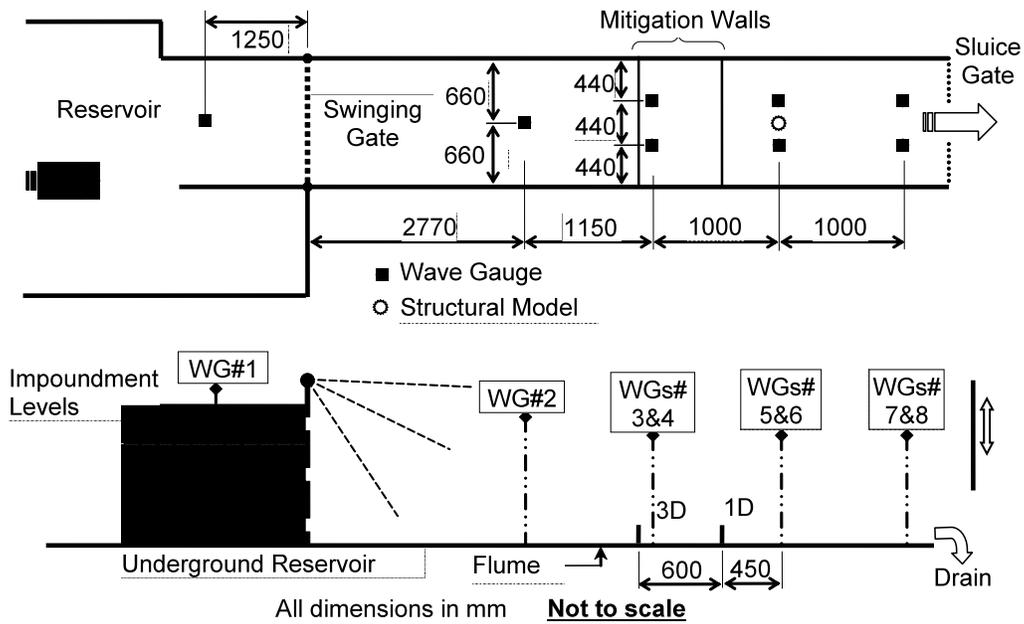
Fig. 6 provides top and elevation view drawings of the experimental setup wherein the location of the wave gauges used to measure the water depth; the structural models and mitigation walls are labeled. Also shown are the three impounded water levels investigated in this experimental program.

Figure 6. Drawings of experimental setup

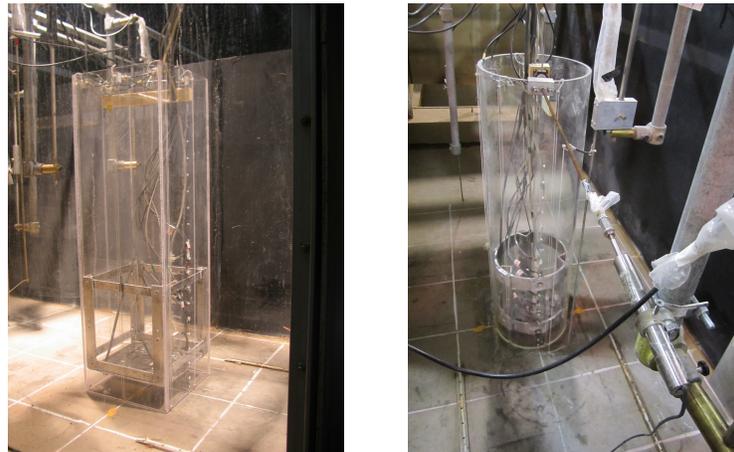
Two hollow structural models, square and circular in cross section, were used in this experimental program. The hollow square structural model has 305 mm x 305 mm cross section, measured to the outside of the section. The walls are 6.35 mm thick and consist of acrylic glass sheets. The hollow circular model, also of acrylic material, has an outside diameter of 305 mm with a wall thickness of 9 mm. Photos of the two structural models installed in the flume are shown in Fig. 7.

Figure 7. Hollow square and circular structural models (Al-Faesly et al., 2012)

The structural models were rigidly fastened to a six degree-of-freedom high-frequency dynamometer that, in turn, was fixed to the floor of the flume. The dynamometer was used to record base shear forces and base overturning moments. Ten pressure transducers were arranged vertically on the outer surface of the structural models to record pressures. Nine of the ten transducers were spaced at intervals of 50 mm starting from the flume floor, while the tenth transducer was positioned 20 mm above the flume floor. Pressures on different faces of the structural models were obtained by rotating the models. An accelerometer and a linear variable displacement transducer were placed at the top of the models to record accelerations and displacements in the direction of the flow, respectively. In addition to the instrumentation placed on the models, the flume was fitted with several capacitance water level gauges (Fig. 6) to record the water depth along the flume. All sensor measurements were recorded continuously during testing, at rates up to 1000 samples per second, to obtain time history responses.

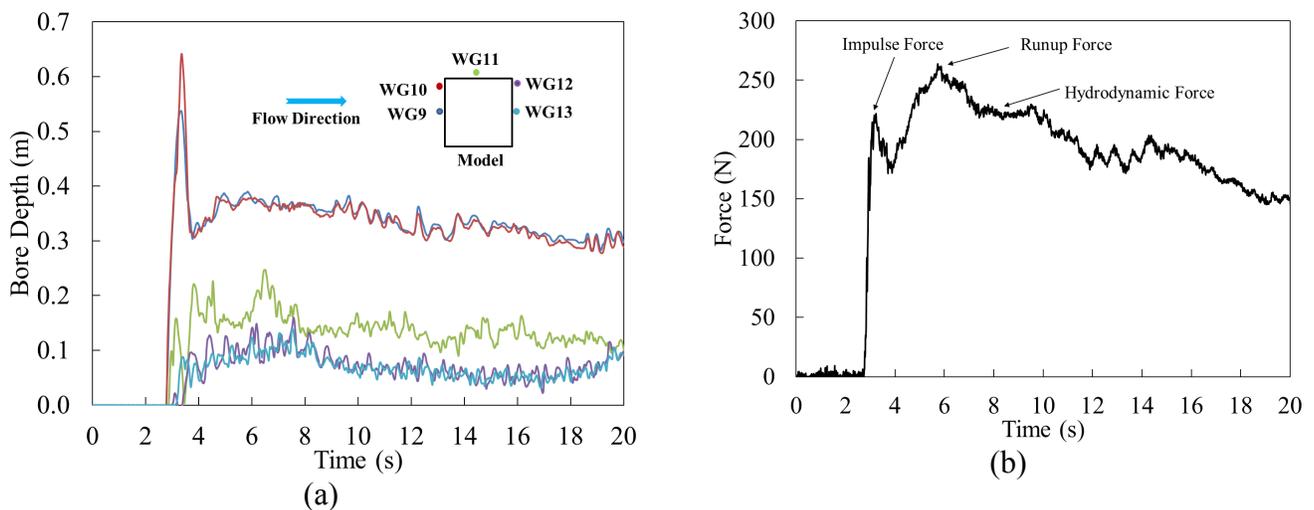
Fig. 8 provides typical bore depth-time history responses recorded by the water level gauges placed around the square model and the base shear force-time history recorded by the dynamometer. These results were generated with the 550 mm impounded water level behind the swinging gate in the closed position. The upstream gauges (WG9 and WG10) measured an instantaneous spike in water level followed by a sharp decrease. This spike coincided with the initial impact of the bore front on the structure and was caused by a thin jet of highly aerated water flowing rapidly up the column face. Immediately following the initial impact, some water was reflected upstream while the advancing bore was surging up the front face of the structural model. This led to a second rise in water level followed by a quasi-static flow condition where the water level remained approximately constant with time.

The base shear force-time history shown in Fig. 8 (b) also reveals an initial spike in force, which occurs when the leading edge of the turbulent bore impacts the structural model. Thereafter, there is a

drop in force as the bore rebounds upstream from the upstream face of the model. This is followed by an increase in force as the bore flow accumulates in front of the structure causing a “bulb-like” wake. The latter mechanism leads to the maximum force experienced by the structural model, and has been termed “run-up force” (Palermo et al., 2009) or “transient hydrodynamic force”. The first impact or impulse force (approximately 222 N) was recorded when the water depth at the upstream face of the column (at gauge WG9) was approximately 0.52 m. The run-up force was approximately 264 N, which coincided with a water level of approximately 0.39 m. The force-time history does not suggest the presence of a steady hydrodynamic force; however, between 8 to 10 s, the force was approximately constant and equal to 220 N. The water level recorded at WG9 was approximately 0.36 m during this time period.

Figure 8. Experiment data for 550 mm impoundment depth: a) bore depth-time histories around the square model; and b) base shear force-time history

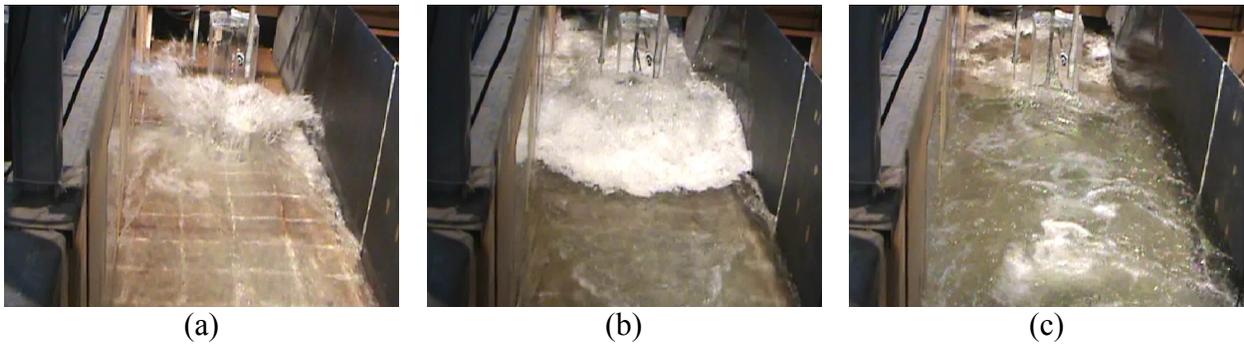
Fig. 9 provides still images from a video recording showing the three stages of flow interaction with the square structural model that coincide with the force components identified in Fig. 8 (b). The three stages are: the reflection of the flow from the front face of the square model after the initial impact; the run-up condition as the rebounding water meets with the advancing bore and surges up the model; and the quasi-steady state flow condition.

Figure 9. Hydraulic bore-structural model interaction: a) initial impact; b) run-up; and c) quasi-steady flow

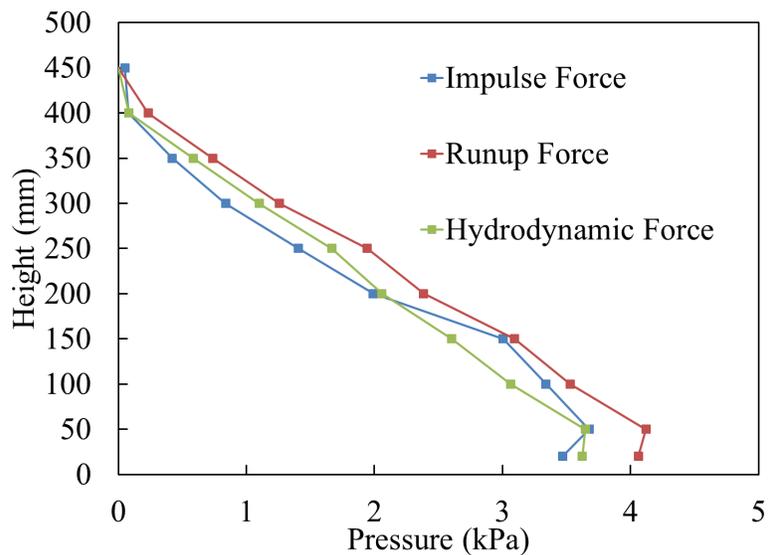
Fig. 10 shows the vertical pressure distributions recorded on the upstream face of the square model at three different times during a single flow-structure interaction. The times correspond to the impulse force, run-up force and quasi-steady hydrodynamic force identified in Fig. 8 (b). For all three times, the pressure profiles were consistent with a hydrostatic distribution. Furthermore, it is evident that all pressure transducers, with the exception of the gauge located 450 mm above the flume bottom, which remained above the maximum water level, recorded pressures. Therefore, at all three times during the interaction, the water level on the upstream face of the square model reached approximately 400 mm. This result is inconsistent with the measurements at water level gauge WG9, and suggests that gauge WG9 recorded a higher water level during the initial impact as a result of the water rebounding off the upstream face of the structure. For the run-up and hydrodynamic force conditions, the pressure gauges recorded a slightly higher water level due to the water surging up the front face of the model.

Figure 10. Vertical pressure distributions on the upstream face of the square model

From the hydrostatic pressure profiles of Fig. 10, the individual force components (i.e. impulse, run-up and hydrodynamic) can be evaluated. For each force component, the height of the pressure was assumed to be 400 mm, while the pressures at the base are approximately 3.67 kPa, 4.12 kPa, and 3.65 kPa, for the impulse, run-up, and hydrodynamic forces, respectively. These pressure values corresponded to the transducer readings 50 mm above the base of the structure. This slightly overestimates the pressure at the base of the structure, but offsets the 0 kPa pressures assumed at the 400 mm elevation. Based on these assumptions, the calculated forces were 224 N, 250 N, and 222 N for the impulse, run-up, and hydrodynamic force components, respectively. These are in close agreement with the base shear forces measured by the dynamometer and illustrated in Fig. 8 (b).

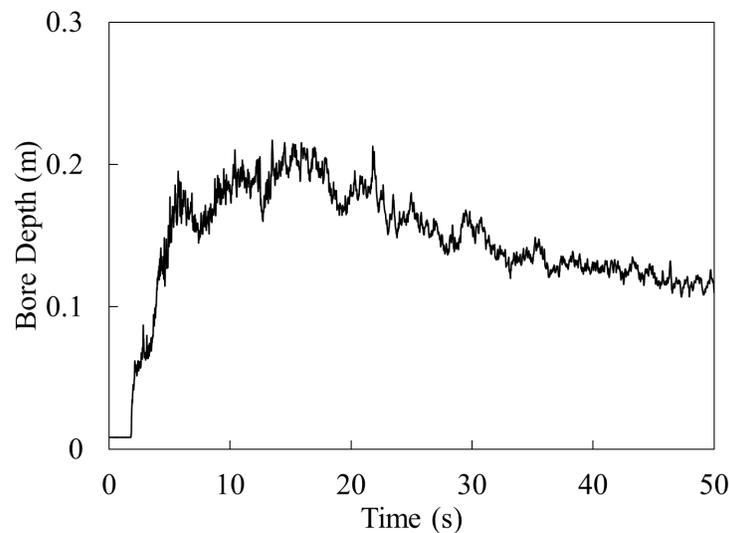
The bore depth measured at the location of the structure, without the structure in the flume, is shown in Fig. 11. For the 550 mm impoundment depth, the water reached a maximum elevation of 0.22 m at approximately 13.5 s. This peak water level was sustained for approximately 10 s as water drained from the impoundment. It is interesting to note that the water level on the upstream face of the structure was approximately 0.4 m based on the pressure readings. Therefore, the presence of the structural model causes a local increase in bore depth near the upstream face. In addition, the influence of the width of the flume relative to the width of the structural model may be a contributing factor.

Figure 11. Bore depth-time history in the absence of the structural model

FEMA P646 suggests that the design run-up elevation,  $R$ , be taken as 1.3 times the maximum run-up elevation to account for uncertainties in determining the design run-up. Using a maximum bore depth of 0.22 m from Fig. 11, and applying the 1.3 factor, Eqn. 2.3 predicts a maximum momentum flux of 0.098  $m^3/s^2$ . The corresponding maximum hydrodynamic force using Eqn. 2.1 is 29 N. This result demonstrates that the momentum flux formulation (Eq. 2.2) provided in FEMA P646 may not be applicable for near-zero sloping beaches. Similar findings were obtained for a number of other similar tests conducted by the authors (Al-Faesly et al., 2012). Note that FEMA P646 (2012) indicates that Eq. 2.2 is based on one-dimensional nonlinear shallow water theory for a uniformly sloping beach.

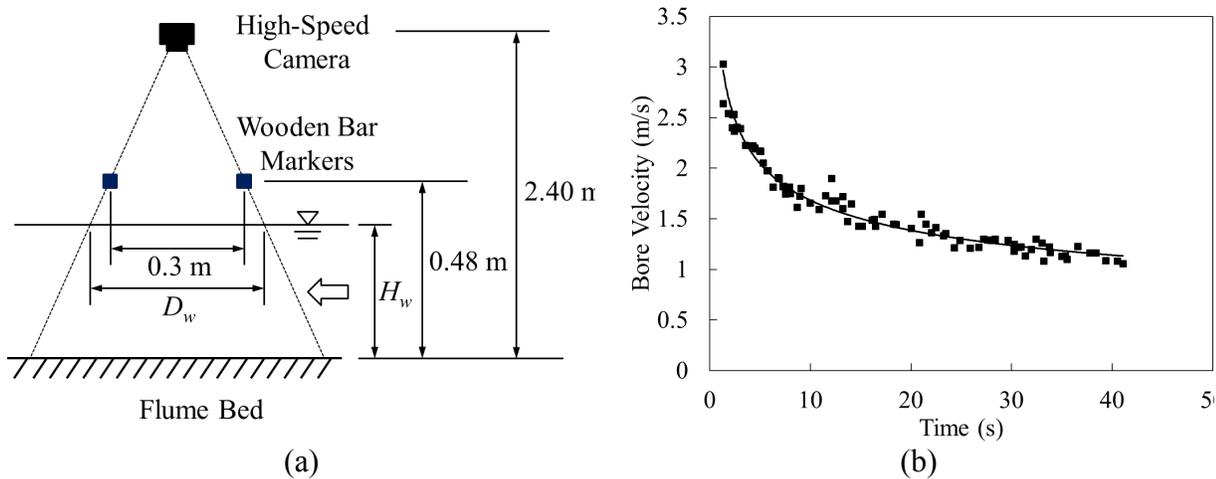
The bore velocity-time history corresponding to the measured bore depth-time history in Fig. 11 is shown in Fig. 12. The velocity was measured by seeding the water with 25 mm square paper beads and tracking their position by analysing images recorded by a high-speed video camera positioned above the flow. The video camera, as shown in Fig. 12 (a), was fastened 2.40 m above the floor of the flume at the location of the structure. Two wooden bar markers were arranged horizontally across the

width of the flume, 0.3 m apart from each other and 0.48 m above the floor of the flume. The distance ( $D_w$ ) travelled by the paper, which was captured by the video camera, varied with the water depth and was adjusted according to the geometry shown in Fig. 12 (a). Therefore, using the adjusted distance and the time for the paper to flow between the wooden markers, the bore velocity-time history at the location of the structural models was calculated (see Fig. 12 (b)). Note that this procedure measures the velocity at the surface of the bore.

Figure 12. Bore velocity for 550 mm impoundment depth: a) velocity tracking setup; and b) measured bore velocity-time history at the location of the structural model

Fig. 12 clearly demonstrates that the bore front velocity was significantly higher than the velocity during the time period from 10 – 20 s in which the bore depth reached a maximum. The surface velocity near the leading edge of the bore was approximately 3.0 m/s, double the 1.5 m/s velocity that prevailed between 10 – 20 s. The bore depth-time history and corresponding bore velocity-time history were used to calculate the momentum flux (the product of the bore depth and the corresponding velocity squared). This parameter is used to estimate the hydrodynamic forces as provided in Eqn. 2.1 and published in FEMA P646 (2012):

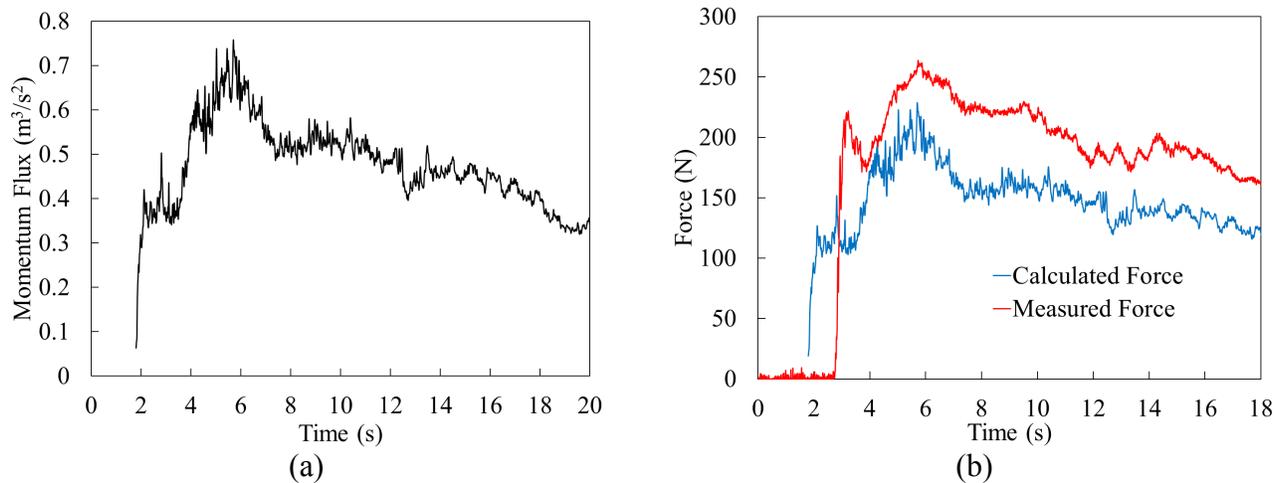
where  $r_s$  is the fluid density, (approximately 990 kg/m<sup>3</sup> for this test program);  $C_d$  is the drag coefficient, assumed equal to 2 for square elements;  $B$  is the width of the element (0.305 m for the square structure); and  $(hu^2)_{max}$  is the maximum momentum flux, which would need to be estimated from the bore depth- and bore velocity-time histories for the site, or obtained by some other means. Fig. 13 (a) provides the calculated momentum flux-time history, while Fig. 13 (b) shows the hydrodynamic force-time history obtained by applying Eqn. 2.1. The base shear force-time history recorded by the dynamometer is included in the figure for comparison. Note that the two force-time histories are offset for clarity.

Figure 13. Calculated values for 550 mm impoundment depth: a) momentum flux-time history; and b) base shear force-time histories

The results illustrate that the calculated forces follow the same trends as the measured forces; however, the calculated force under-estimates the maximum force in this case. The peak calculated force was approximately 229 N, while the peak recorded force was 264 N or 15% larger. This difference in peak force may be attributed to a number of sources, such as measurement error, variability between repeated tests, the confining effect of the flume walls, and error in the assumed value for  $C_d$ .

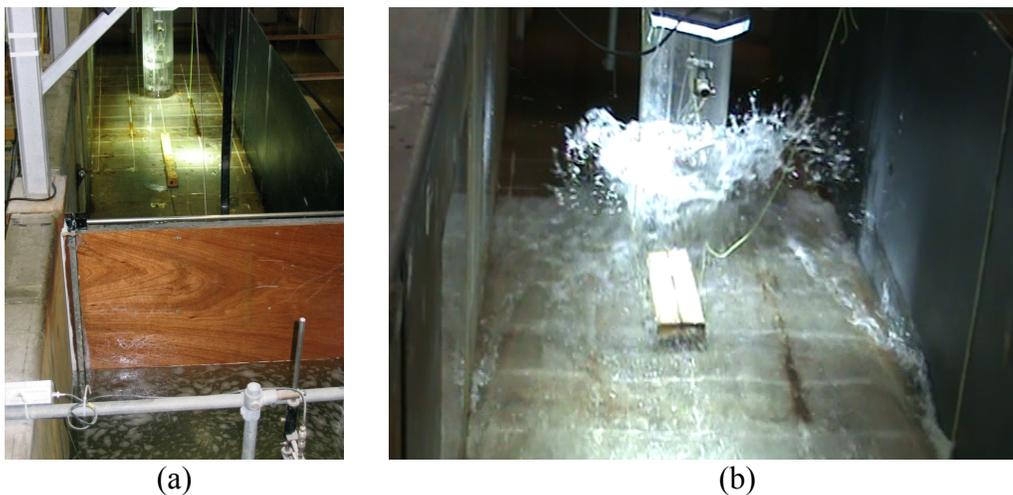
The field surveys conducted after the 2004 Indian Ocean, 2010 Chile and 2011 Japan tsunamis highlighted the severe impact of debris on structures. As part of this experimental program, debris impact tests were conducted using 3 wood logs of different size and mass: 77 mm x 77 mm x 490 mm (1.09 kg), 77 mm x 77 mm x 916 mm (2.19 kg), and 77 mm x 154 mm x 490 mm (2.26 kg). Fig. 14 (a) shows the setup of a typical debris impact test prior to the opening of the gate, and Fig. 14 (b) captures the impact of the log against the circular structural model. The wooden logs were placed on the floor of the flume at pre-determined distances from the structural model before each test. As the bore advanced downstream from the gate, the flow accelerated and transported the debris, causing it to impact against the structural model.

Figure 14. Debris impact testing: a) initial setup; and b) debris impacting circular structural model  
Fig. 15 provides a typical impact test result for the circular structural model. The results correspond to the 1.09 kg wood debris initially located 1.75 m downstream from the swinging gate.

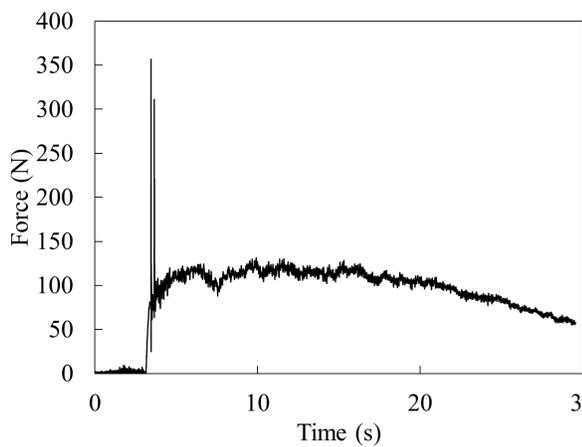
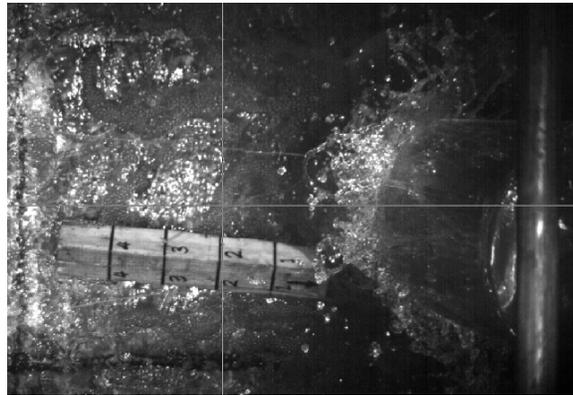
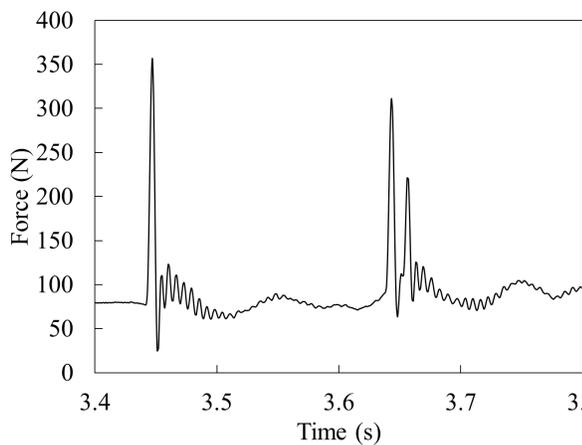
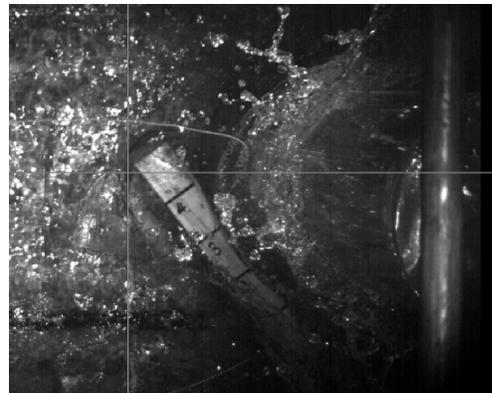
Fig 15 (a) provides the entire base shear force-time history where the spike in force is attributed to the wood log impacting the structural model. The first impact occurs shortly after the bore front reaches the upstream face of the model. The first impact force was approximately 279 N (net of the force imposed by the flow of the water) with a corresponding rise time of 0.005 s. Fig. 15 (c) shows the base shear force-time history between 3 and 4 s where two additional impacts are evident. They occur due to the log rebounding from the structure and then being carried back into the structure by the bore. The second and third net impact forces were approximately 220 N and 144 N, respectively, with rise times of 0.005 s and 0.007 s. Fig. 15 (b) demonstrates that the first impact was a direct longitudinal strike, while the second and third impacts were more of a transverse strike (Fig. 15 (d)). The second and third impact forces were smaller than the first impact force due, in part, to the reduced velocity of the log and the change in orientation from longitudinal to transverse.

Figure 15. Debris impact test results: a) base shear force-time history; b) orientation of first impact; c) base shear force-time history of subsequent impacts; and d) orientation of subsequent impacts

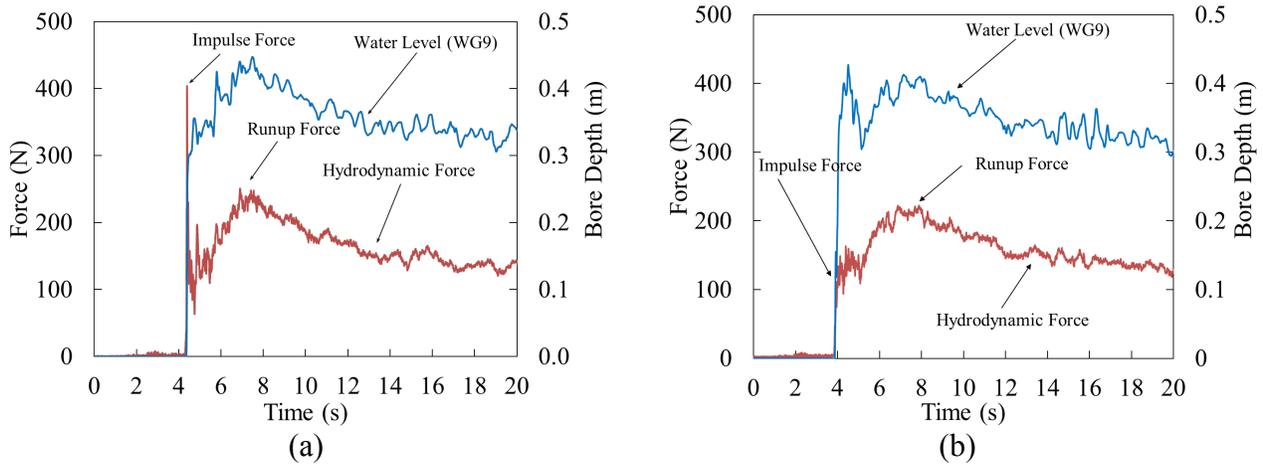
Another interesting phenomenon observed during the experiments was the influence of the condition of the flume bed. Fig. 16 compares the base shear force-time histories experienced by the square structural model when subjected to flows generated by the 550 mm impoundment depth. Fig. 16 (a) illustrates the measured response under dry-bed conditions (an initial condition with negligible water on the flume bed), which typically corresponded to the first test of the day. This condition could reasonably represent in-land ground conditions during the arrival of the first tsunami wave. Fig. 16 (b) provides the measured response under wet-bed conditions (an initial condition wherein the flume bottom was covered by a thin film of water), which corresponded to all subsequent tests. This could be representative of the ground conditions for subsequent tsunami waves. The corresponding bore depth-time histories are also superimposed in Fig. 16.

Figure 16. Effect of dry bed vs. wet bed for 550 mm impoundment water level: a) time histories for dry bed; and b) time histories for wet bed

The bore depth-time histories recorded by WG9, located near the upstream face of the structural model, for the wet- and dry-bed conditions are similar. The base shear force-time histories are also similar beyond the initial impulse force. The only notable difference is the initial impulse force. For the dry-bed condition, the initial impulse force was approximately 404 N, while under the wet-bed condition; the initial impulse force was only 134 N. It became evident from observing high-speed video recordings that the leading edge of the bore front was steeper in the case of the dry flume bed, which is attributable to the greater friction generated by the dry-bed surface. This phenomenon resulted in the significantly higher impulse force for the dry-bed condition.
