SCIENCE OF TSUNAMI HAZARDS

Journal of Tsunami Society International

THE 7.8 M_w EARTHQUAKE AND TSUNAMI OF 16th April 2016 IN ECUADOR: Seismic Evaluation, Geological Field Survey and Economic Implications

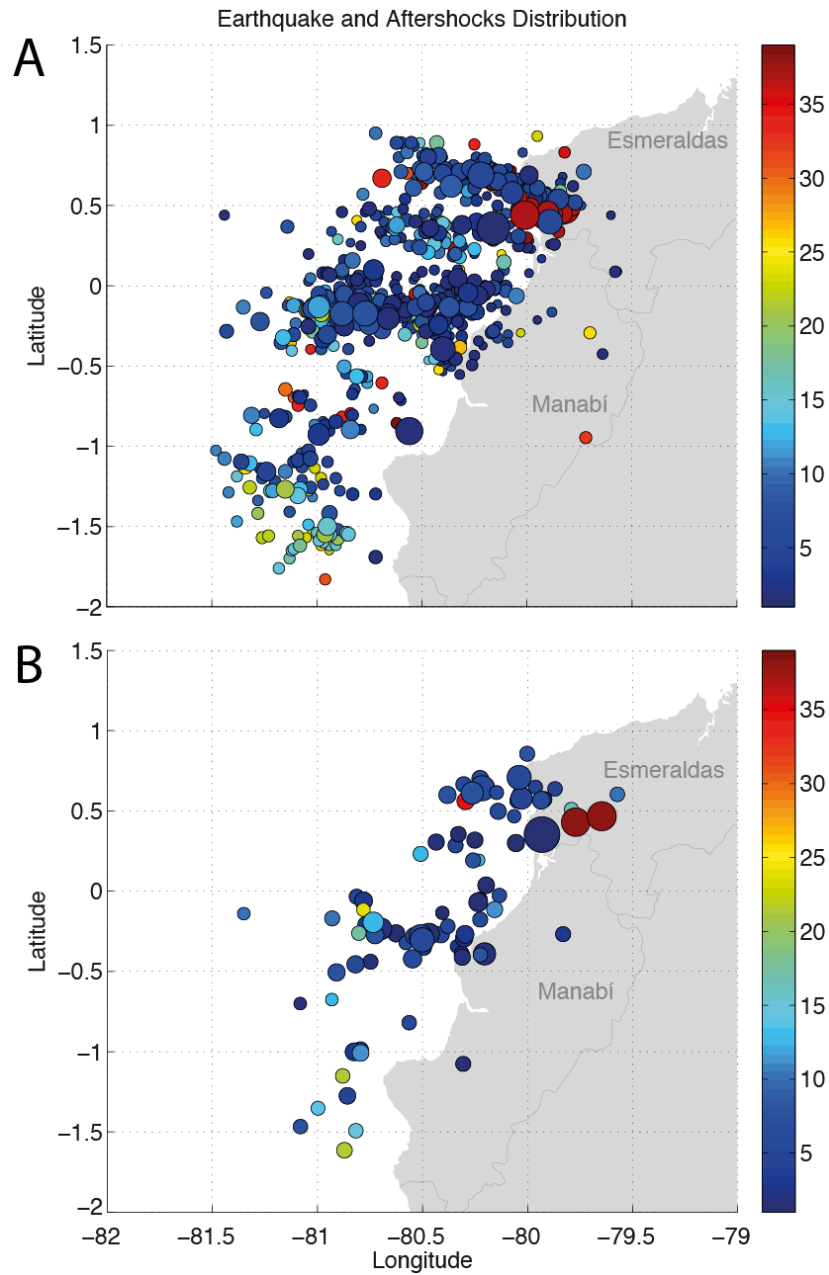
Fig. 5: Spatio-temporal distribution of the April 16, 2016 M_w 7.8 Muisne, Ecuador Earthquake and aftershocks registered by IGEPN (a) and USGS (b) within the affected area [79.5W - 81.5W, 2S - 1N] from April 16th (dark blue) to May 20th (dark red).

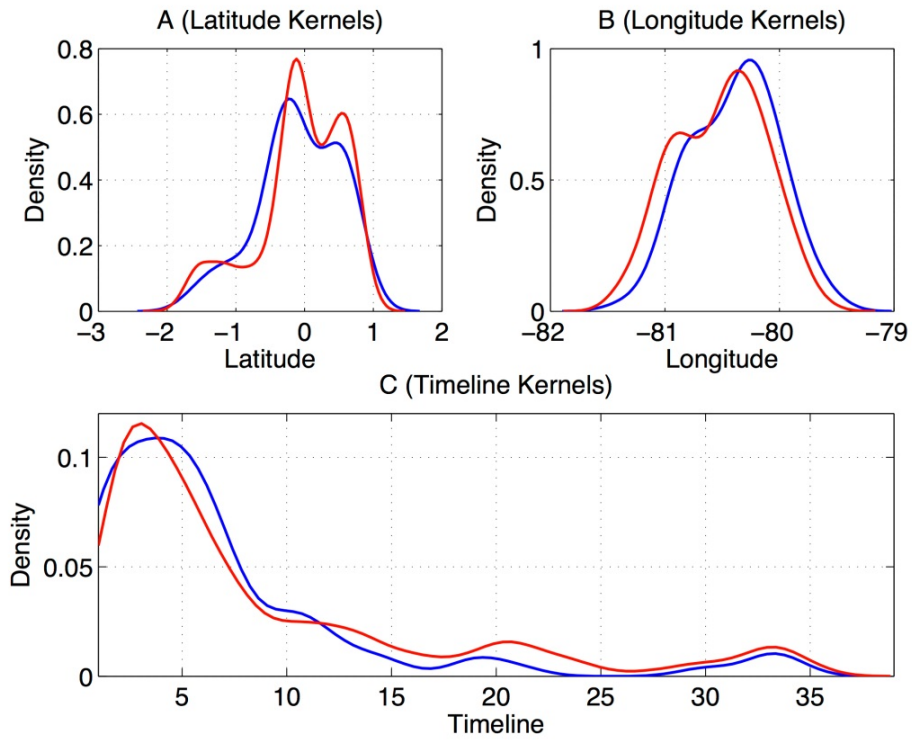
Fig. 6: Latitude (a) and Longitude (b) kernels distribution of the April 16, 2016 M_w 7.8 Muisne, Ecuador Earthquake and aftershocks registered by IGEPN (red) and USGS (blue) within the affected area [79.5W - 81.5W, 2S - 1N]; (c) corresponding timeline kernels distribution. , Observations presented up to May 20th2016.

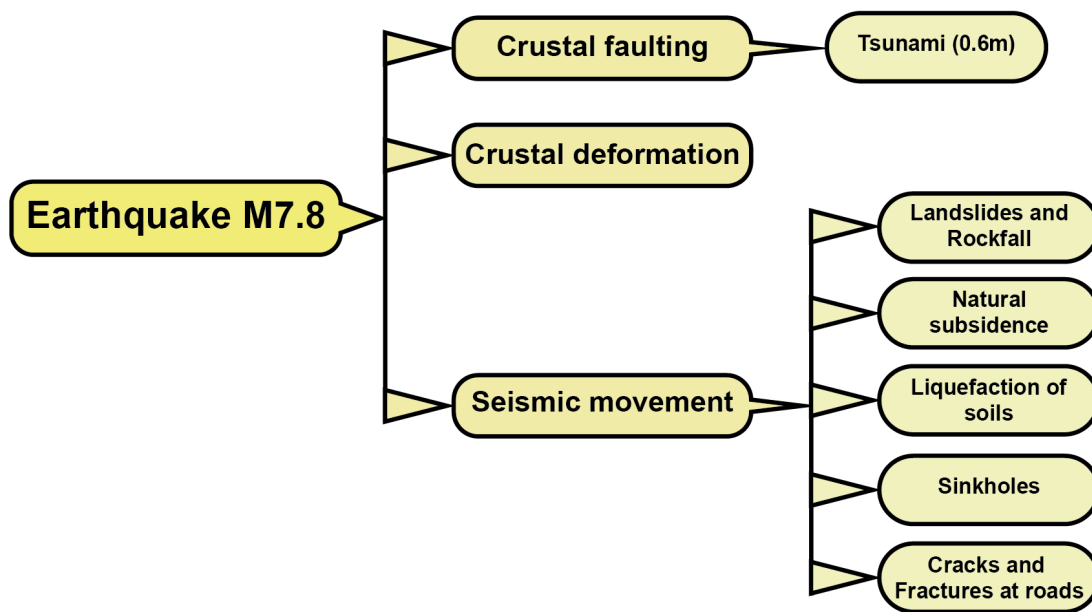
Fig. 8: Primary and secondary effects during and following the main $M_w7.8$ earthquake (Chunga et al., 2016).

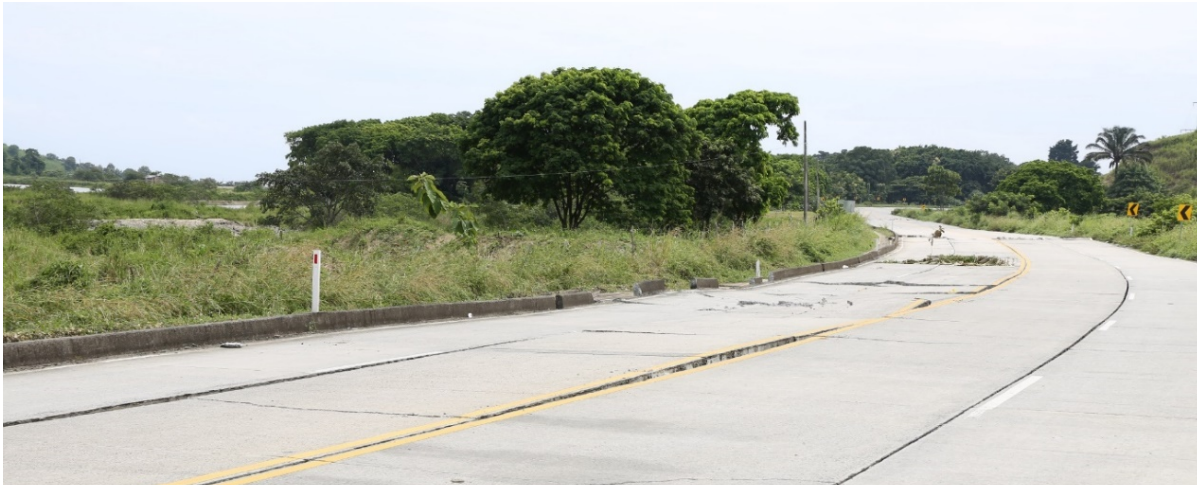
Fig. 9: Deformations along concrete-made road between Pedernales and Coaque, with diagonal and transverse fractures 10 to 14 cm wide. geomorphological floodplain features. ESI Intensity of IX and coordinates (UTM: 602.858mE 10.003.638mN).

Visible damage of the concrete road between Pedernales and Coaque included uplift internal steel beams that formed transverse fractures with openings of 8-15 cm (Fig. 9). In paved roads, the deformations generated bigger fractures, reaching 20 to 30 cm openings within transverse esruptur (Fig 11; Jama, UTM Coord. 584.676mE, 9.982.122mN.).

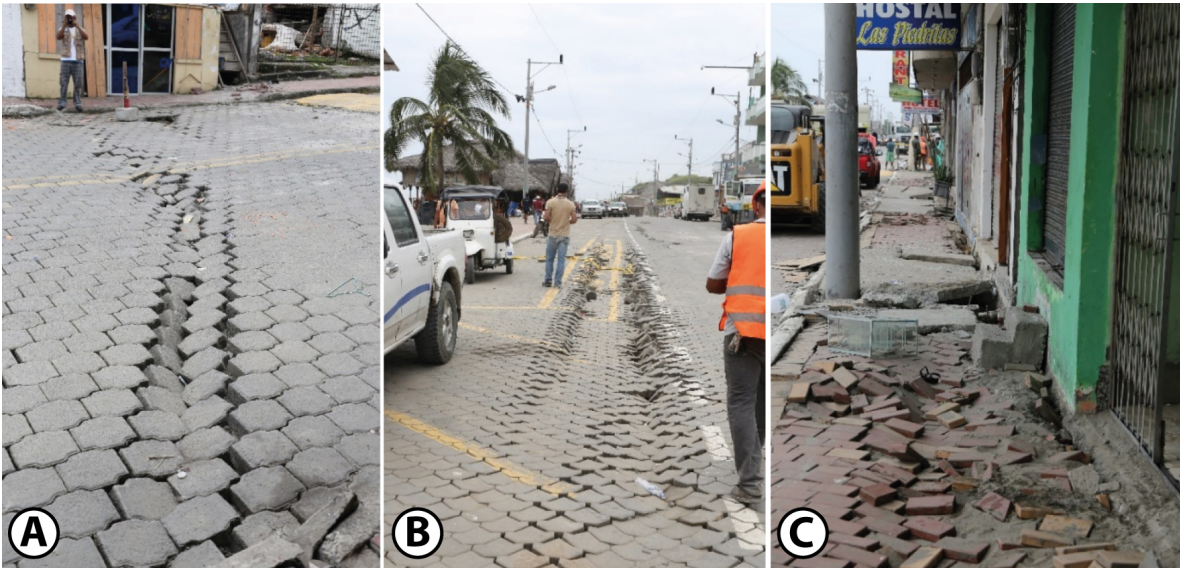
Seismic effects in the epicentral area based on geomorphological features of supratidales coastal plains, floodplains, coastal terraces and depressions (filled areas) and between hills (Jama) were mapped. The supratidal areas experience wavy surface deformations, affecting buildings and streets (Figs. 9, 11). Some cobblestones were re-arranged as folds with vertical displacements from 8 to 10 cm recorded in Pedernales. Subsidence of cobblestone layers were commonly observed as shown on Fig. 10.

Fig. 10: Wavy deformations on the beach boardwalk and streets of Pedernales, with re-arrangements of cobblestones in folds. ESI Intensity of IX to X and coordinates (UTM: 604.756mE 10.007.656mN).

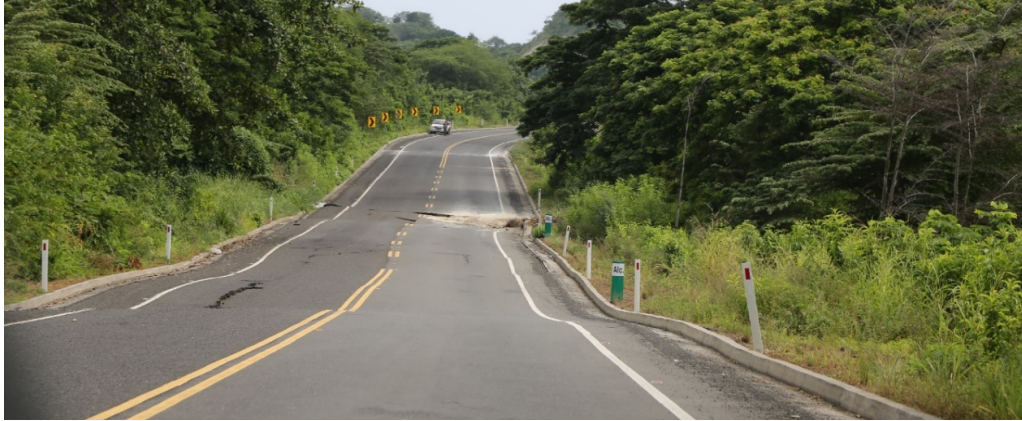
Fig. 11: Deformation in Jama paved road, with transversal fractures 20 to 30 cm wide and longitudinal fractures of 12 to 15 cm. Cracks observed in the free field soils reached 1 m. ESI Intensity of IX and coordinates (584.676mE 9.982.122mE).

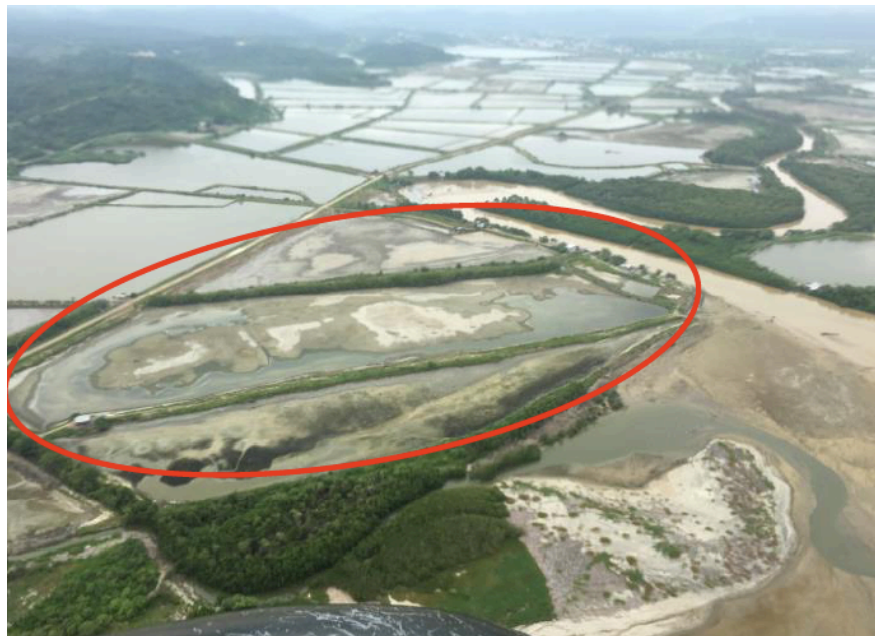
In the natural terrain or soil of this area, crack openings reached 1 m. Such deformation characteristics were also observed in Pedernales and Coaque, but not towards the north, in Cojimies and Chamanga, confirming that the earthquake was felt strongly towards the south of the epicenter. In some other sites, the land appeared to have settled with apparent evidence of liquefaction in flooded areas and sand ejecta as shown on Fig. 12.

Fig. 12: Liquefaction evidence from GEER helicopter flyover of Manabí coast (Nikolaou et al., 2016), close to Jama ($0^{\circ}12'31.7''S$, $80^{\circ}15'22.5''W$ UTM coordinates 9976918.8N, 582762.5E).

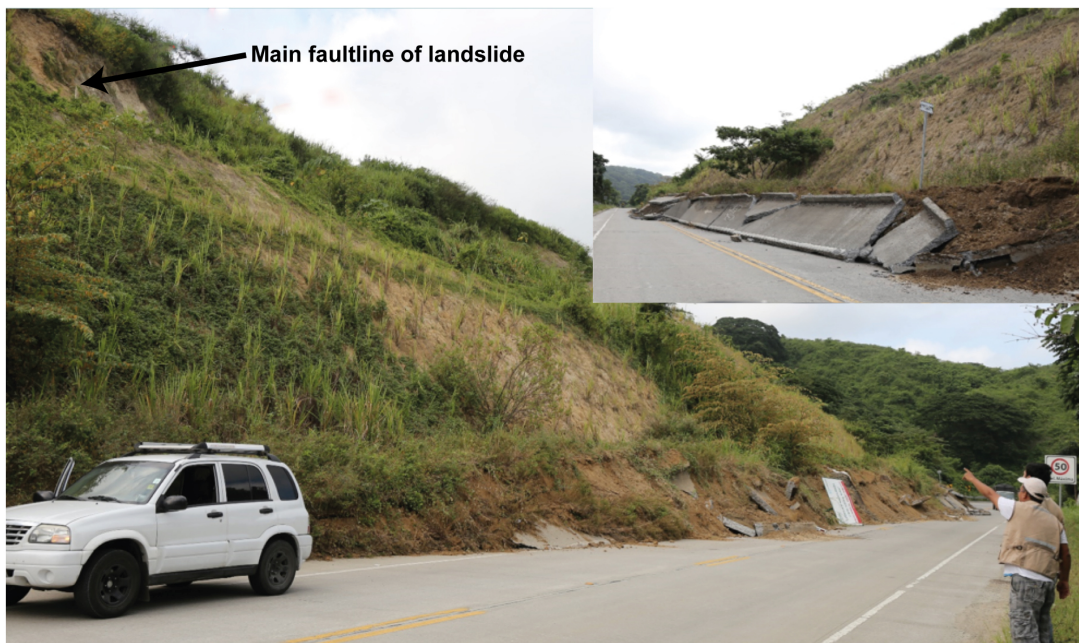
Landslides and rockfalls of natural slopes were evident throughout the affected area (Fig. 13) with 126 reports out of 290 sampling stations. Stabilized slopes also reported damages in the epicentral area (Fig. 14), like in the northern side of Canoa, where part of a slope was deformed with a displacement escarpment. Field inspections indicated that the slope was likely not adequately stabilized, since the top did not have any stabilization work done and presented cracks and fissures with water runoff (Fig. 15).

Fig. 15: Rotational slip in the road El Rosario – Canoa with evidence of escarpment at the slope and damages on the bicycle path and concrete road. Approximately 400 m³ of material slipped (Chunga et al, 2016.). ESI Intensity = VIII and coordinates (UTM: 561.268mE 9.952.722mN).

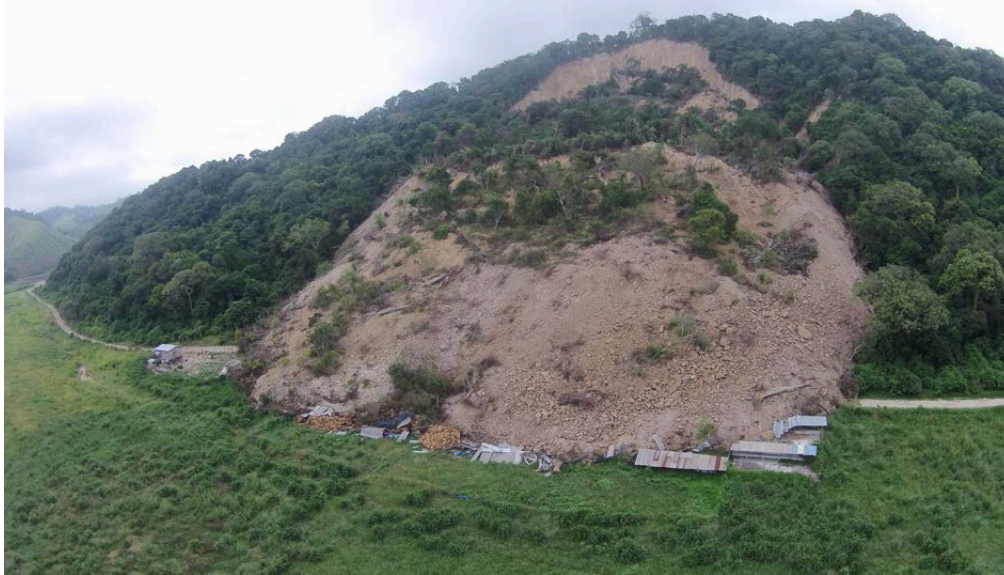
Fig. 16: Aerial photo of landslide on San Vicente-Canoa local road by GEER (Nikolaou et al., 2016). (GPS: 0°33' 5"S, 80°25'42"W UTM coordinates 9939051.9N, 563610.3E)

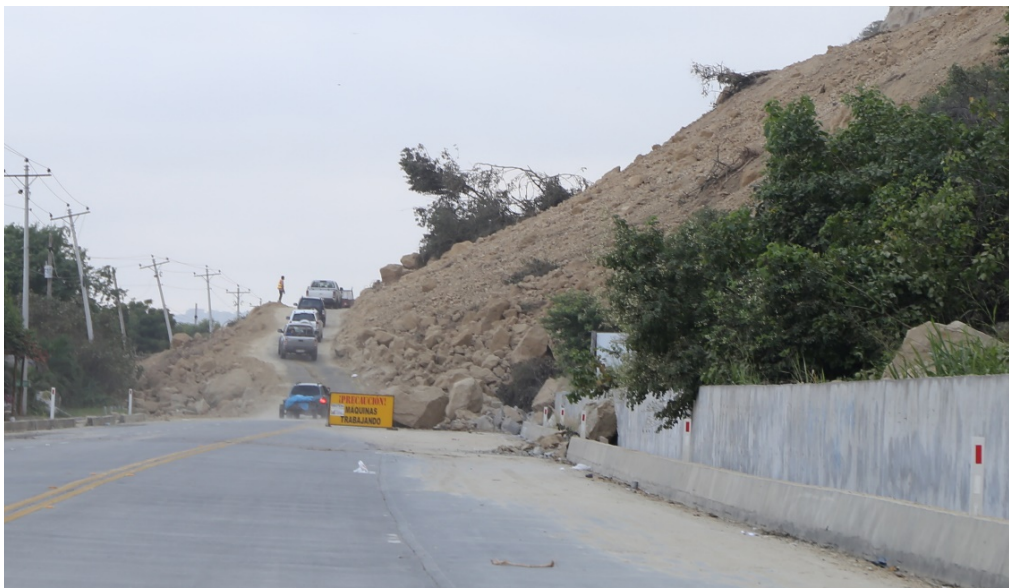
Fig. 17: Massive rockfall, which covered and destroyed completely the paved road with some 10,000 m³ at Boca de Briceño. Intensity ESI = VIII, coordinates (561.647mE 9.944.416mN).

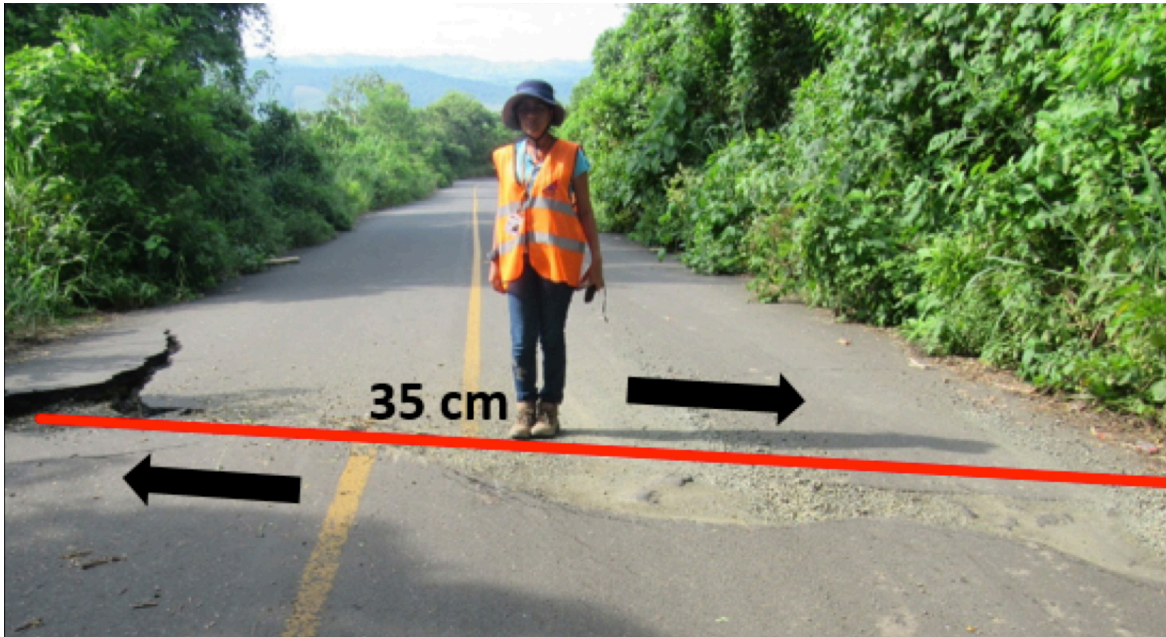
Fig. 18: Transcurrent displacement of ~35 cm on the paved road between San Vicente-San Isidro. Intensity ESI = VIII , coordinates (UTM: 573.419mE, 9.939.274mN).

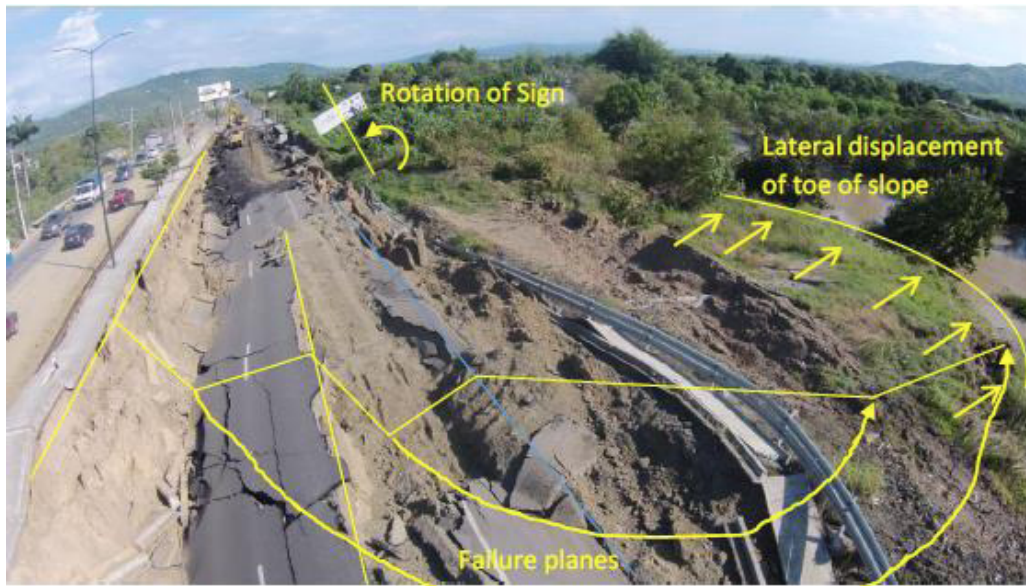
In Crucita, vertical settlements and lateral deformations due to instability may be attributed to liquefaction, although surface manifestation of sand ejecta was not identified in reconnaissance. The assumed failure planes on Fig. 19 appear to be either along the interface between the embankment and the foundation soils (planar surface), or through the foundation soils. The latter, indicative of a more circular surface failure, may be due to liquefaction-induced softening that allowed the reduced-strength soil to shear during the earthquake (Nikolaou et al., 2016).

Fig. 19: Aerial view of embankment failure with assumed movement and failure modes marked with yellow at Mejia Bridge. Coord. UTM: 558.990mE 9.890.563mN. Intensity ESI = VIII. GEER-ATC report (Nikolaou et al., 2016).

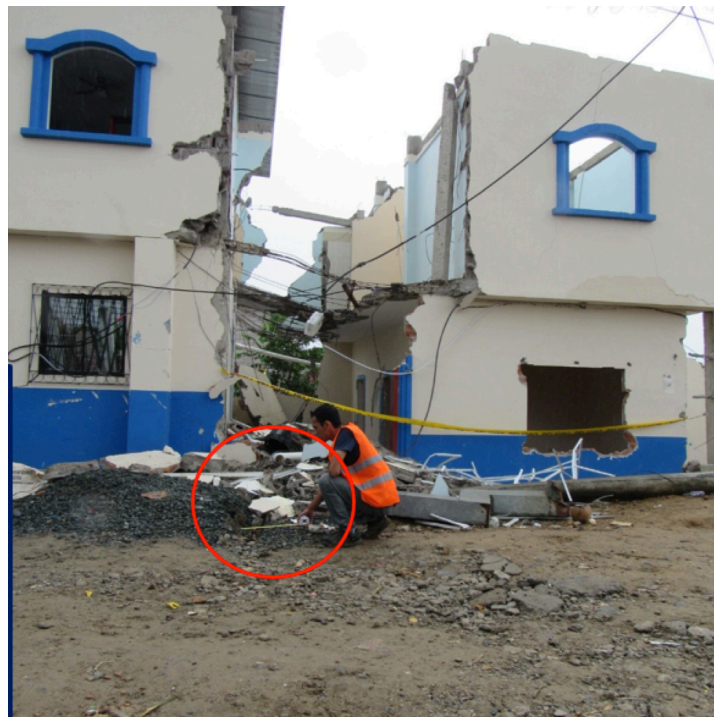
In Chamanga, several homes collapsed with evidence of 15-25 cm wide cracks due to lateral deformations in the supratidal coastal zone (Fig. 20) and bearing failures. In total we documented 65 sites in the cities and towns of Cojimies, Pedernales, Coaque, Jama, Canoeing, San Vicente, Bridge Mejia, Junin, San Isidro, Chone, Manta, Rocafuerte and Chamanga with similar damage patterns.

Fig. 20: In Chamanga cracks in natural terrain with openings of 15 to 25 cm and collapses of buildings. Intensity ESI = VIII. Coordinates UTM: 616034mE 10009804mN.

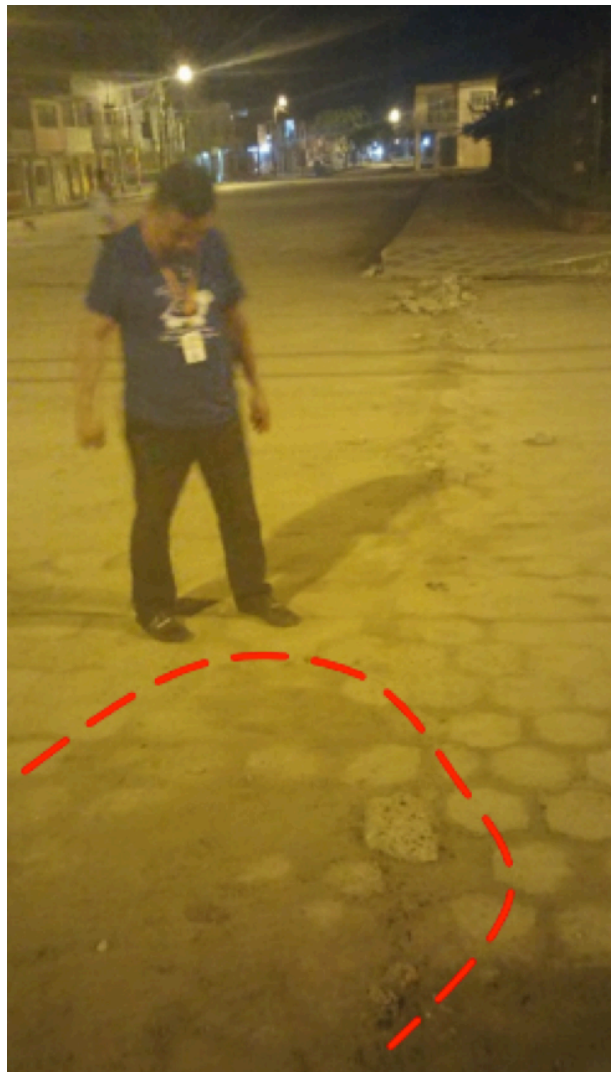
Furthermore, soil liquefaction and sinkholes were observed along with sand boils in Muisne, Boca de Briceno and Tosagua (Figs. 21 to 24). The soil profile in these areas consists of sedimentary features formed in active and abandoned floodplains as well as paleo-surface meanders, which is combined with shallow ground water table. Observations of lateral spreading at river banks and road cuts on slopes included crack openings of up to 30 cm. In the central park of the island Muisne, a variety of sand boils (Figs. 17 and 18) between 50 cm to 80 cm in diameter were formed 1 minute after the main M_w 7.8 earthquake, submerging two blocks of the park and leaving behind wavy deformation patterns in sidewalks, cobbles and streets. Similar phenomena were re-activated during the strong aftershocks of May 18th, 2016 (11:46 a.m) that reached M_w of 6.8.

Fig. 21: Liquefaction evidence in the central park of Muisne Island. Intensity ESI = VIII and coordinates (UTM: 609170mE 10067485mN).

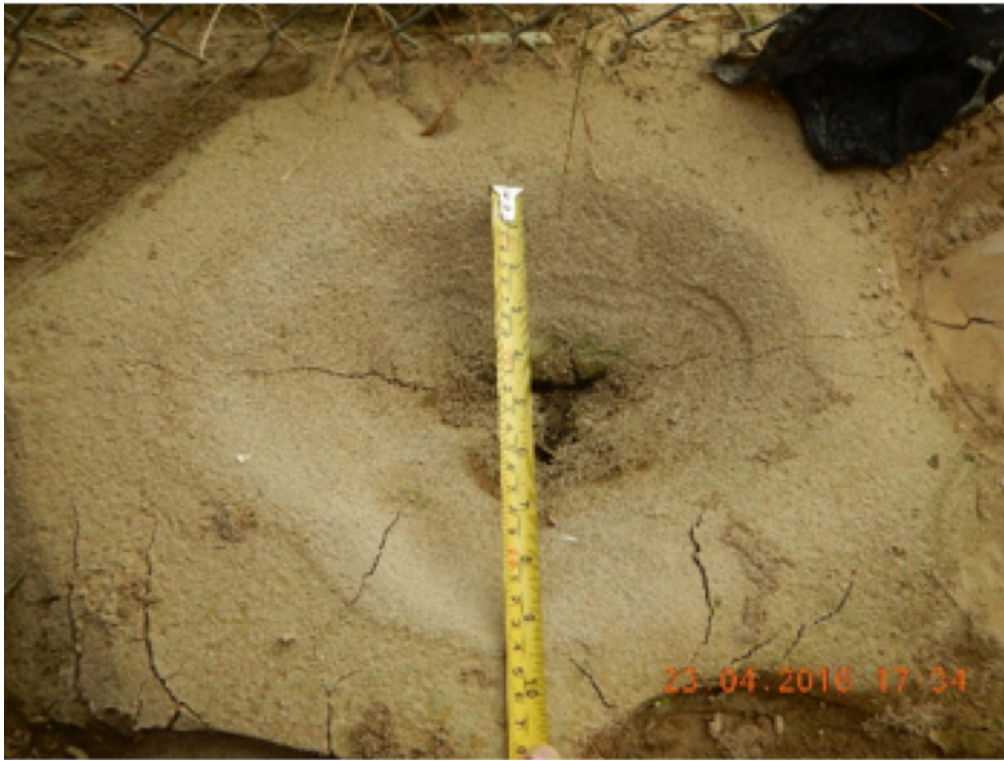
Fig. 22: Sand boils with a diameter of 30 to 55 cm. 585364mE 9913357mN. Intensity ESI = VIII.

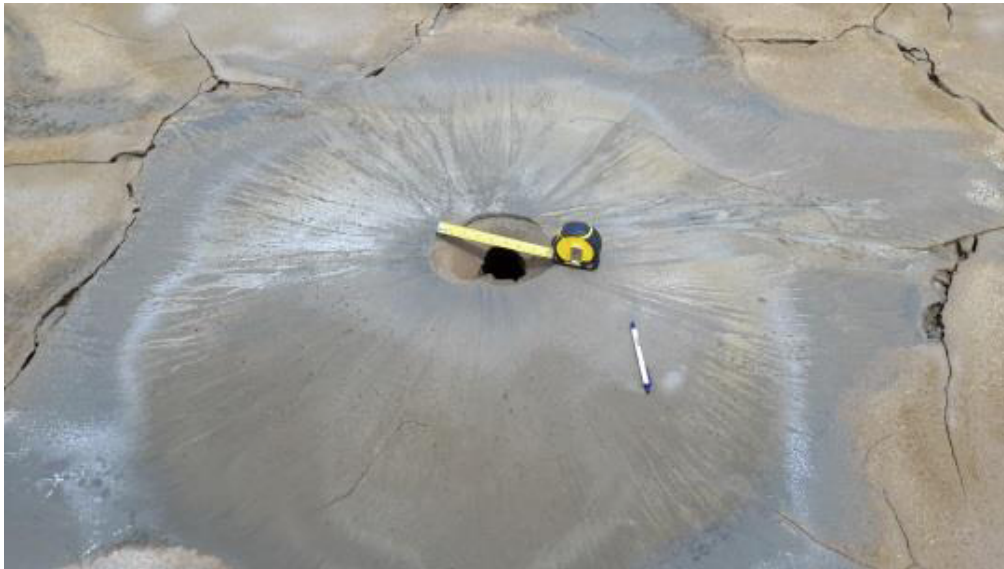
Fig. 23: Boca de Briceno Bridge liquefaction evidence in free-field and adjacent to embankment footing from GEER observations (Nikolaou et al., 2016) (GPS: 0°30'59"S, 80°26'31"W) UTM coordinates 9942920.8N, 562096.1E.

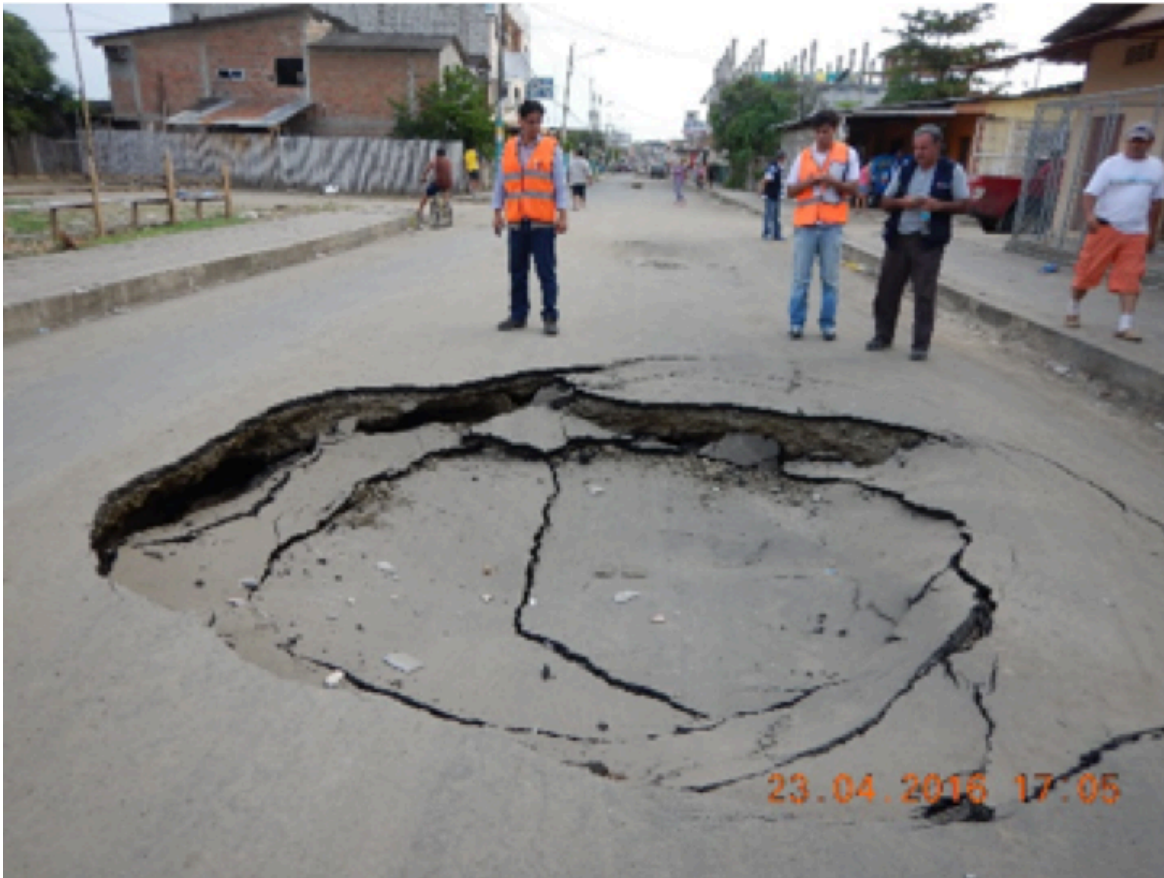
Fig. 24: Sinkhole at Tosagua village site with diameter of 2-3 m within floodplain and evidence of subsidence. Tosagua has been settling above an abandoned meander plain.

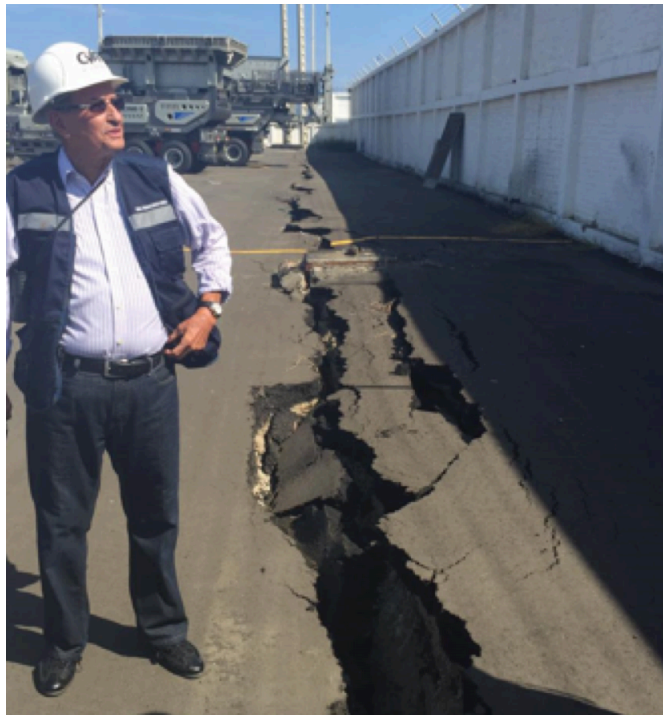
Fig. 26: Longitudinal fractures in middle of a paved road in Manta, with openings of 2 to 5 cm, lateral spreading. Coord. UTM: 531735mE 9894912mN.

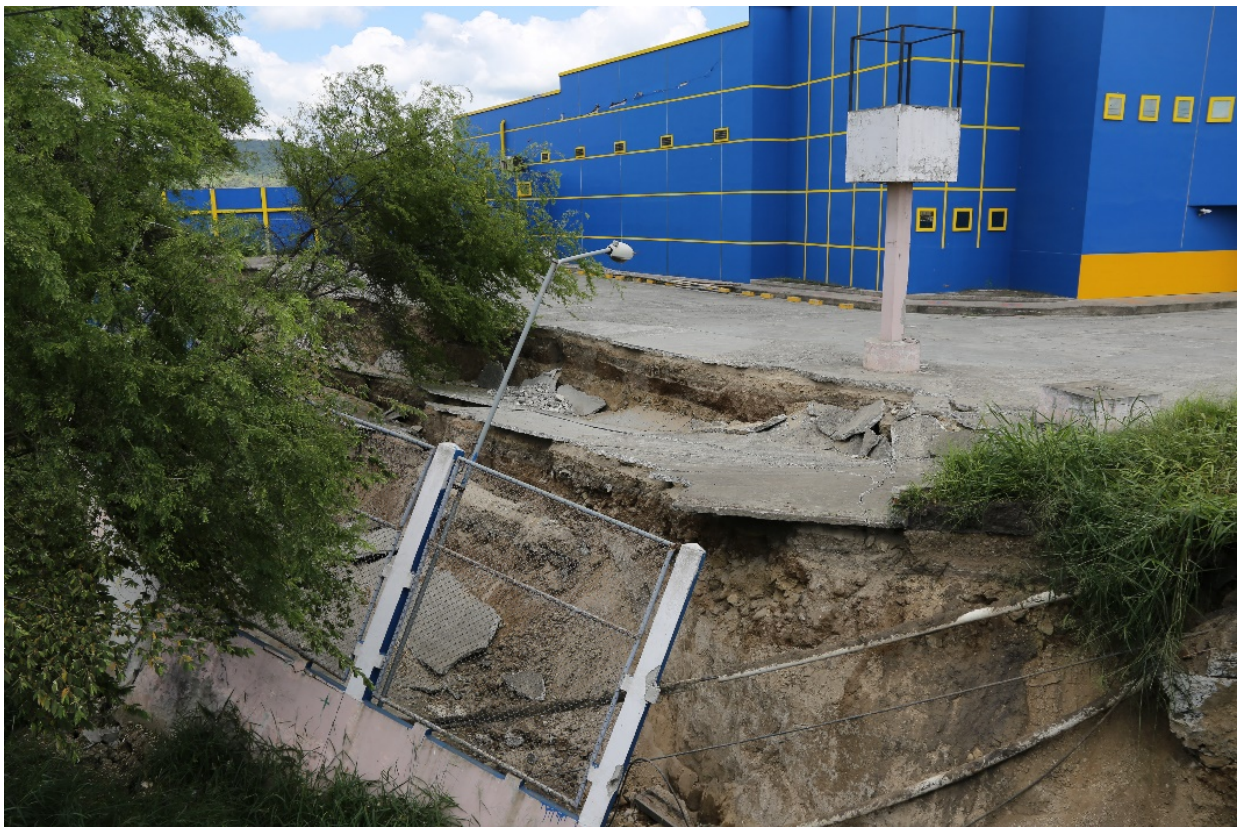
Fig. 27: Rotational and lateral ground deformations in the river margin, partial bridge collapse, easily eroded sandy material. Intensity ESI = VII. Bolvoni site, Portoviejo. 560261mE 9882769mN.

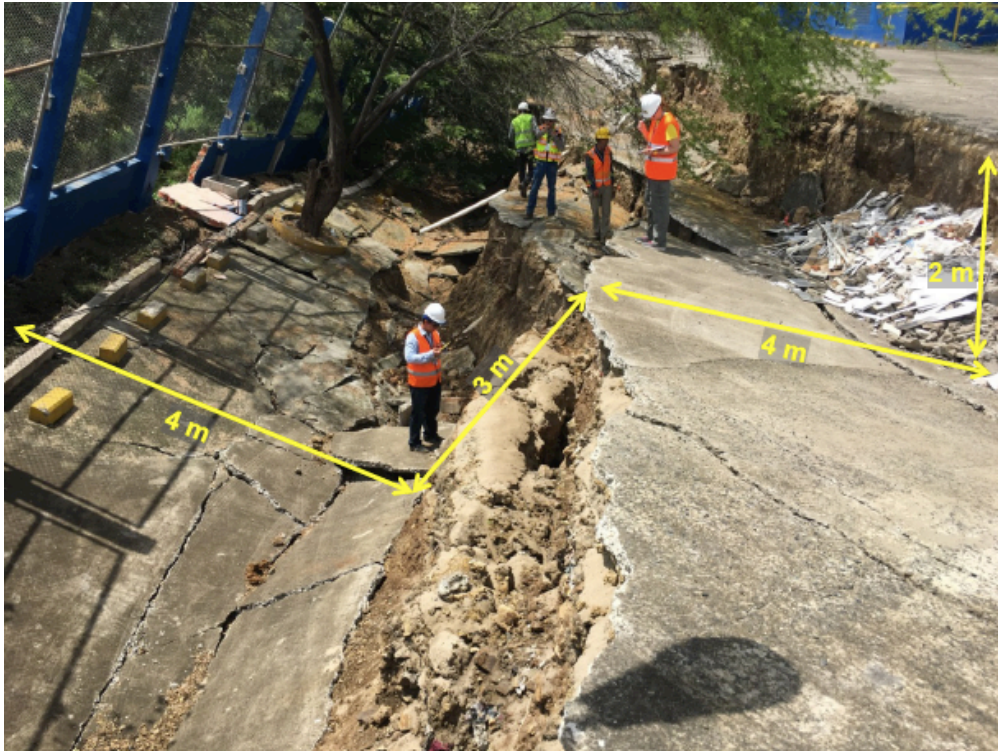
Fig. 28: Wall at Portoviejo Velboni site recorded by GEER-ATC (Nikolaou et al., 2016): Slope failure showing two primary slip surfaces and wall rotating, following the slope movement (GPS: 1°3'37.8"S, 80°27'29.3"W).

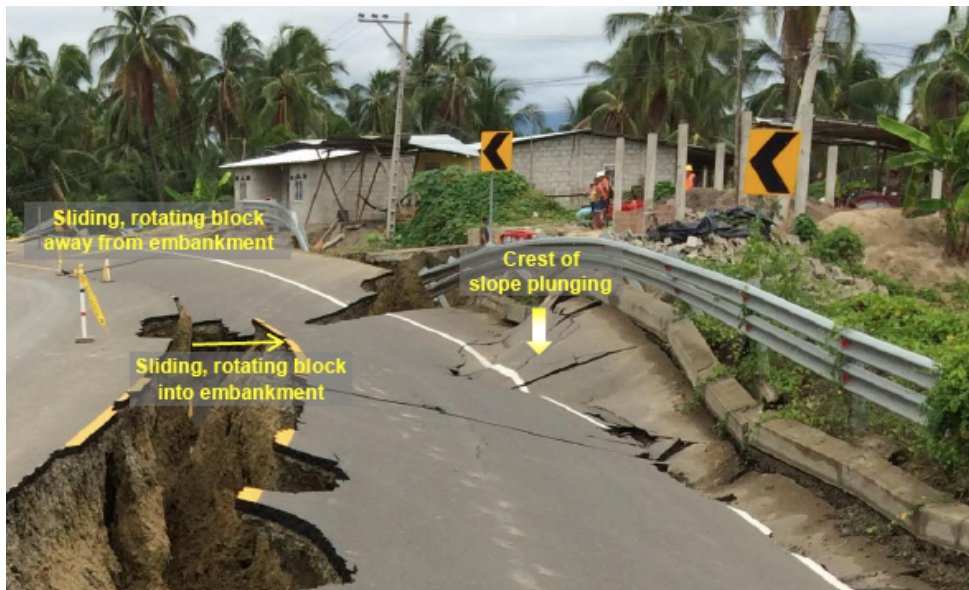
Fig. 29: Rio Chico: Settlement and rotation of block in foreground and circular global failure in background recorded by GEER-ATC (Nikolaou et al., 2016). (GPS: 0° 58' 36.6" S, 80° 25' 23.7" W).

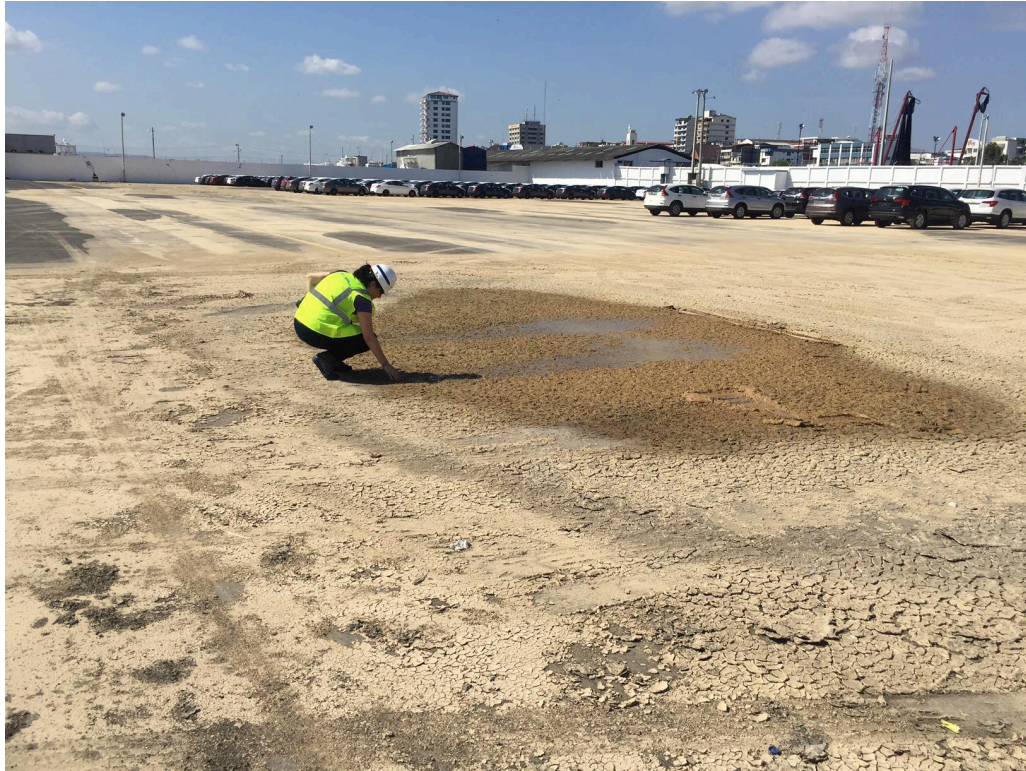
Fig. 30: Concentrated sand blow in the center of pavement in the Manta Port parking area (GPS: 0°56'27.6"S, 80°43'29.4"W). (Nikolaou et al., 2016)

Soil liquefaction in alluvial plains such as this observed by GEER-ATC (Nikolaou et al., 2016) at the parking lot of the Manta Port affected networks and induced collapses in Manta where lateral spread was also observed (UTM coord: 605.574mE, 9.925.484mN and 606.894mE, 9.928.506mN). In Chone, subsidence due to soil liquefaction in alluvial terraces has been recorded (UTM Coord. 598.218mE, 9.921.753mN).

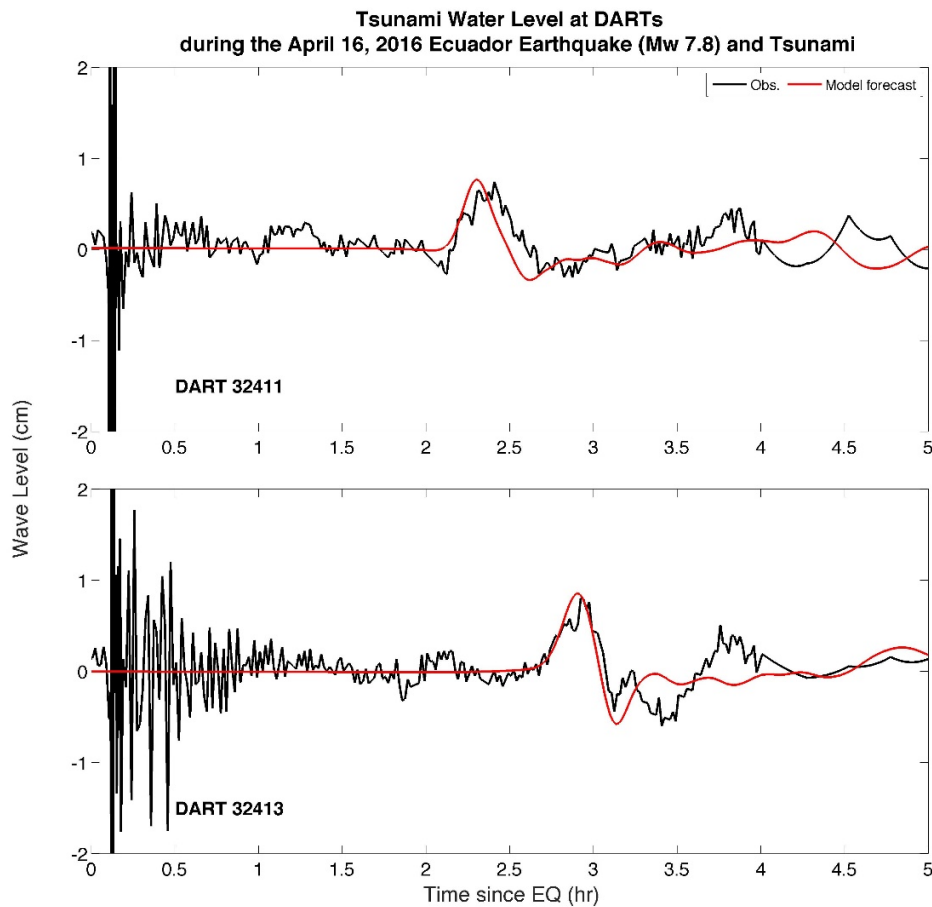
32413 DART

Nevertheless, the earthquake of the 16th of April 2016 in Ecuador triggered a tsunami, registered by 32411 and buoys from NOAA located at Panama and Peru basins, respectively. These were registered 2 and 3 hours after the earthquake when the waves passed over their positions. Furthermore, the seismic waves propagated over the seabed, affecting the register at the pressure sensor of these buoys until an hour after the earthquake (Fig. 32). Roughly, we were able to observe that the period of the tsunamis has been about 40 minutes with amplitude close to 1 cm.

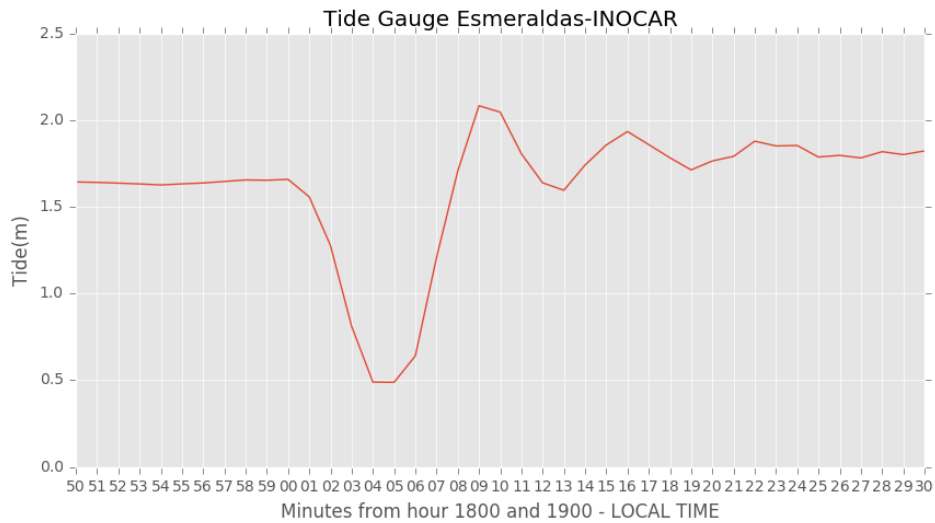
The Esmeraldas Port registered the arrival of tsunami with the receding of the water, which started at 19:00. From 19:06 to 19:09, the tide gauge registered the arrival of the tsunami crest which meant a rate of change in water level of ~50 cm/min. (Fig. 34)

Fig. 34: Mareogram from Esmeraldas Tide Gauge. Note that tsunami crest wave arrived 6 minutes after the event. Source: INOCAR

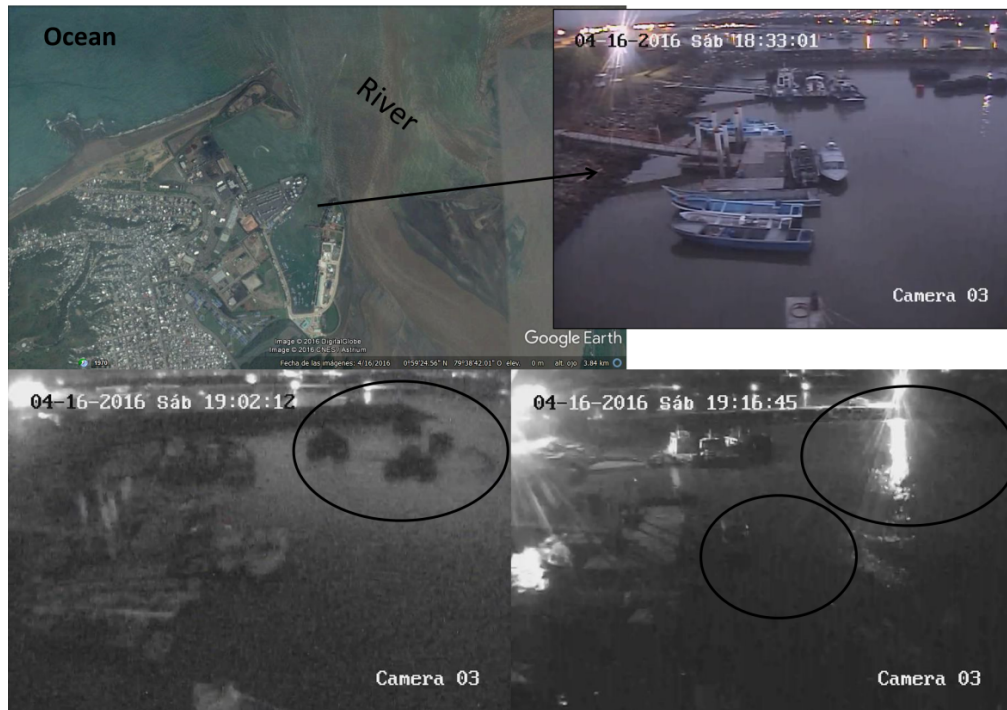
Even with the arrival tsunami at low tide, the Esmeraldas Port was exposed to strong residual currents. Some small boats and buoys were moved from these anchorage sites due the strong currents (Fig. 35).

Fig. 35: Fishing Port Esmeraldas. At the time of tsunami arrival, a small boat and buoys set were moved from their anchorage. Source: ECU911
