## SCIENCE OF TSUNAMI HAZARDS

### MECHANISM OF SEAWALL DESTRUCTION DUE TO TSUNAMI

Tsunami that happened along Sunda Strait on 22 December 2018 was generated by the collapse of the flank of Anak Krakatau volcano in Indonesia. The tsunami hit Lampung and Sunda beaches areas. The hydrodynamic force of the tsunami hit everything on its course severely including seawalls that are used to protect the beach from erosion due to wind waves. The stability of such structure is limited to the design wind wave force. Tsunami has a significantly different nature compare to wind waves. When tsunami arrives at the coastline it becomes surge where, the water particle movement is significantly faster than that of the wind waves. The force of such high speed of water particles at a seawall may destroy and drag away the material far from the original location. Field survey was conducted following the tsunami event along Sunda Strait in Banten area. Based on the survey, a hydraulic simulation of seawall destruction due to tsunami was carried out in the laboratory. It was found that there were two distinct mechanisms of seawall destruction. When the land support of the seawall is relatively weak, the

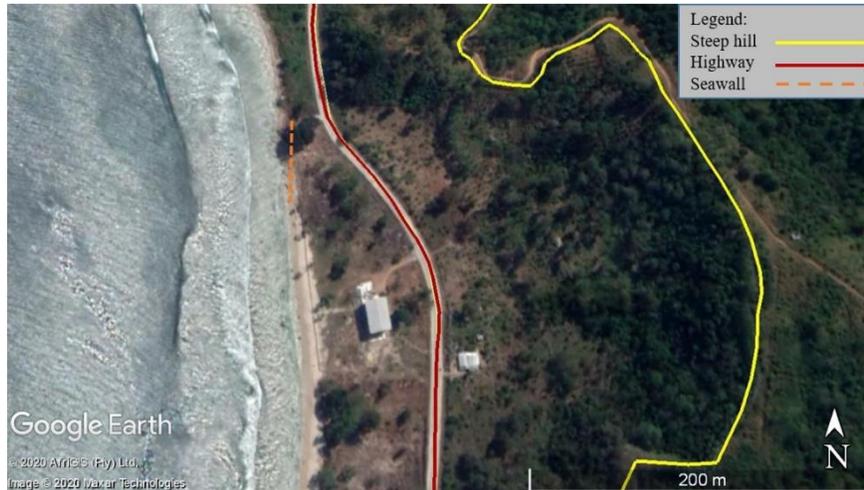
Figure 13. Seawall position and the surrounding area (map from Google Earth Image)

Unlike the debris of seawall at Chery Beach, the ruins of Batu Hideung seawall were scattered at the seaside. There could have been a number of possibilities. First, the seawall was strong enough to withstand tsunami during run up due to the land support but, it was failed during the rundown time as no land support at the seaside. Second, there was a possibility that the area behind the seawall was inundated due to tsunami coming from adjacent location since the tsunami height along Sunda Strait varied considerably. For example, the inundation at Sukarame Beach were approximately 2 to 3 meters, however at TPI Sukanegara (fish auction) which is only 660 m to the north, there was almost no inundation on land. A witness whose house is near the fish auction explained that he could only saw that, the water of the river mouth (used as fishing boat harbor) was turbulence and that the boats were hitting each other very hardly. He confirmed that there was no significant inundation at that location. The rundown of the tsunami was probably the one that destroyed the seawall. This analysis is also supported by the fact that there is a hill at 120 m to 200 m (Figure 13) behind the seawall that could have reflected back the tsunami, increased the inundation depth behind the seawall and dragged the seawall and the ruins to the sea side. During the survey, the positions of the ruins were documented. The schematic positions of the original seawall and the ruins are given in Figure 12. The cross-section was measured along the original seawall position at every 4 m distance. The location of the seawall and the surrounding area are presented in Figure 13.

As can be seen in Figure 12, the ruins of seawalls were found in front of the seawall original position at the beach side. It indicates that the debris were dragged seaward during tsunami run-down. In Figure 12, it can be seen that the debris were scattered with the longest distance of the debris from its original position was approximately 10 m. Actually, this is the preferred condition for a ruined seawall since, the dragging of debris seaward is expected not to harm anyone or buildings in the sea. Since seawalls are normally built along the coast to protect the beach from erosion, it is important to understand the failure mechanism which dictates the direction of the debris when the seawall is destroyed by tsunami.

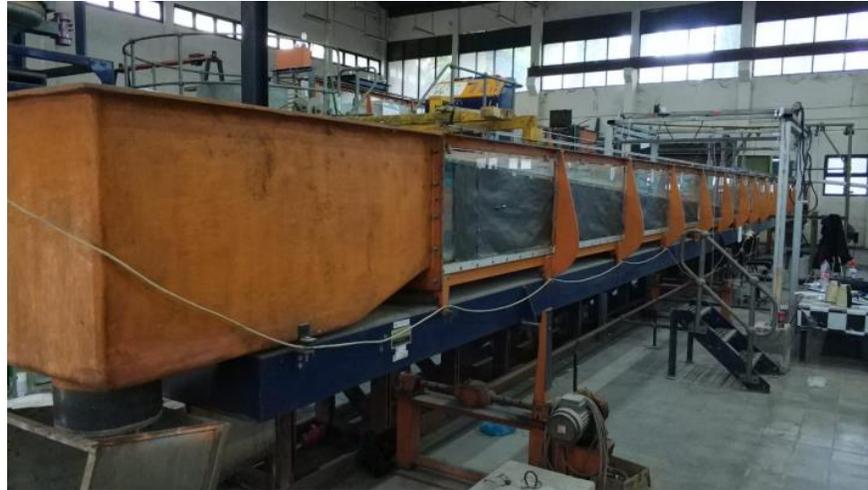
Figure 14. The flume equipped with dam break generation facility

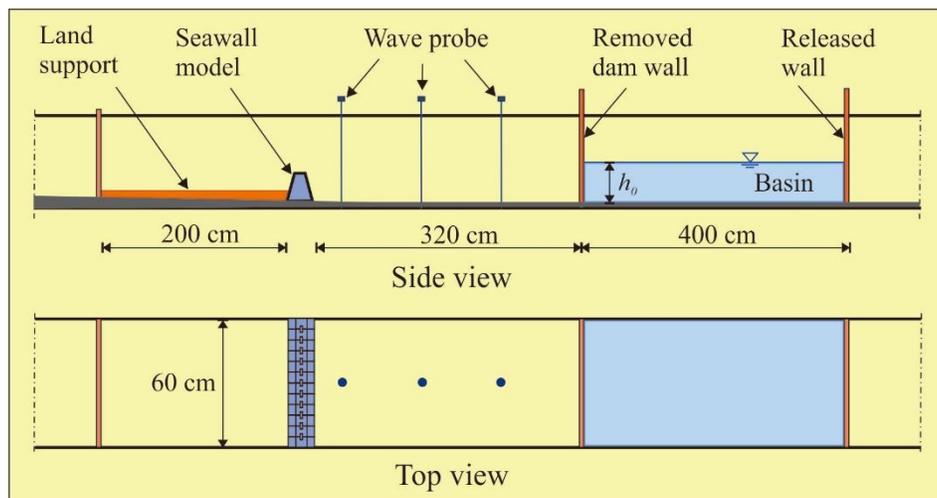
Figure.15. Schematic of seawall model test

Based on the field condition, a seawall model was set as follows. The seawall model was set perpendicular to the flume. At the boundary (flume walls) the seawall was fixed to simulate the undestroyed part in the field. In order to simulate the strength of the seawall, the wedges that connected the seawall was varied. These were 0.0 m (without wedge), 0.014 m, 0.021 m, and 0.028 m long. After the seawall was set, tsunami surge was generated from the upstream by lifting the gate that separate the flume into two parts. The upstream part was the basin that represent the source of tsunami. As the gate was lifted, the water in the basin surged toward the seawall model. The water depth of the basin was varied to create various tsunami inundation depths and forces on the seawall model.

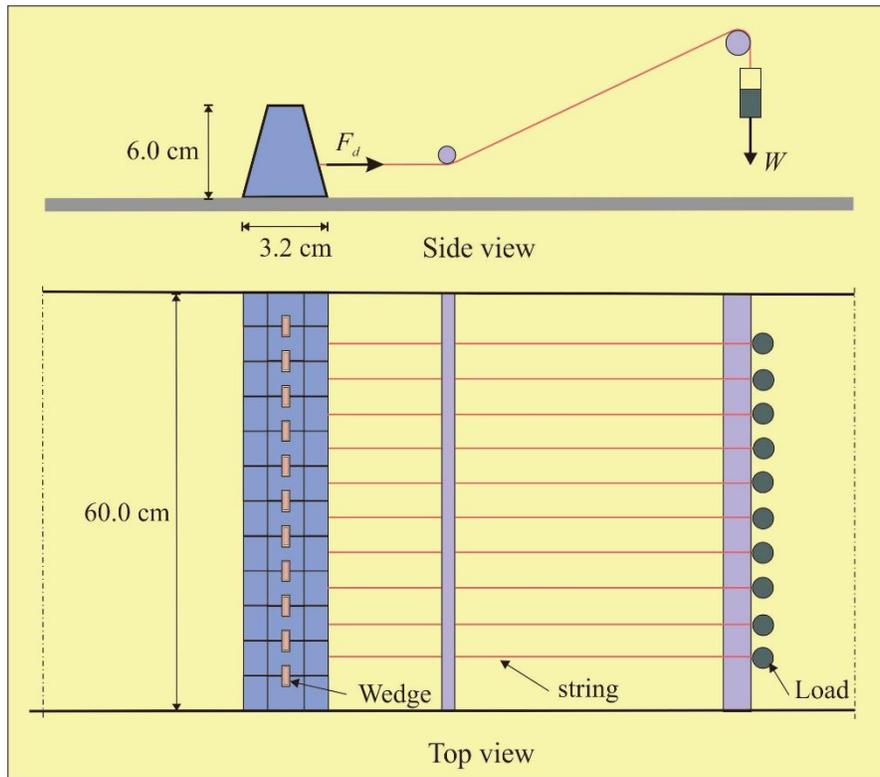
Prior to the hydrodynamic simulation, the seawall (cemented seawall) model strength was observed. This was conducted by a pull-out experiment that was aimed to observe the seawall model's strength under uniform static force. The sketches of the pull-out test are presented in Figure 16. The wedges that linked between two loose seawall element models are shown as small brown rectangles. The results of the loading tests for various wedge lengths are presented in Table 1.

Figure 16. Schematic of pull out test
